# NGC Base HV Breakdown Study

D. Mack

9/20/21

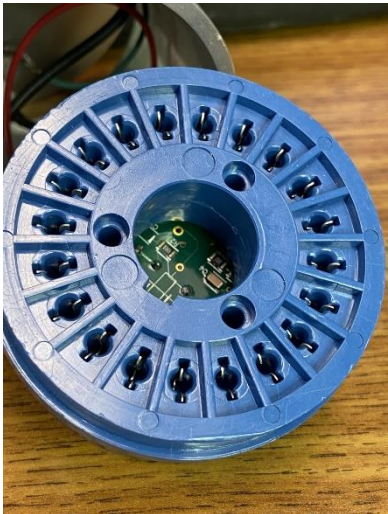
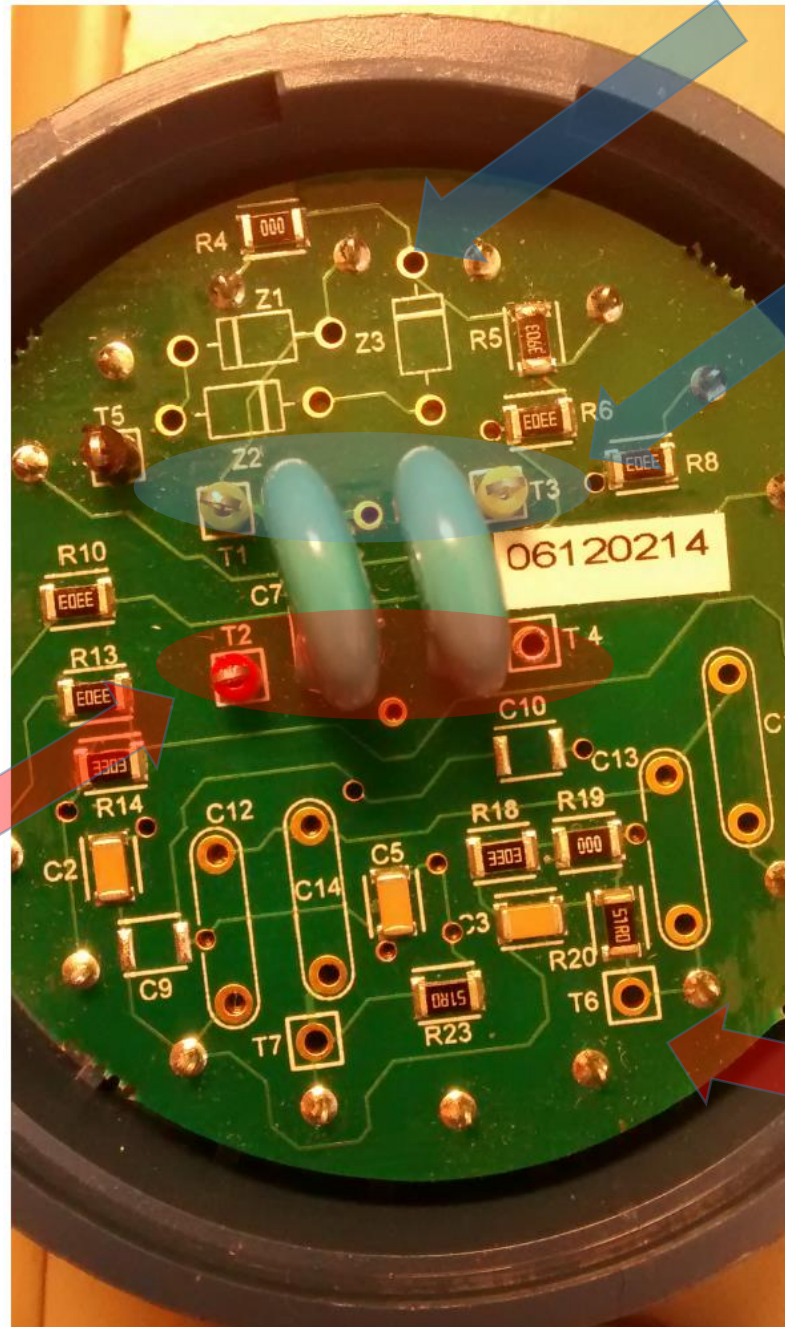
**Photo at right:**

This is the socket-divider assembly as it arrives from ET.

Half the components are on the other side of the board and can't be examined. (see photo below)

The HV line goes to T2.

The ground and anode signal lines go to T1 and T3, respectively.

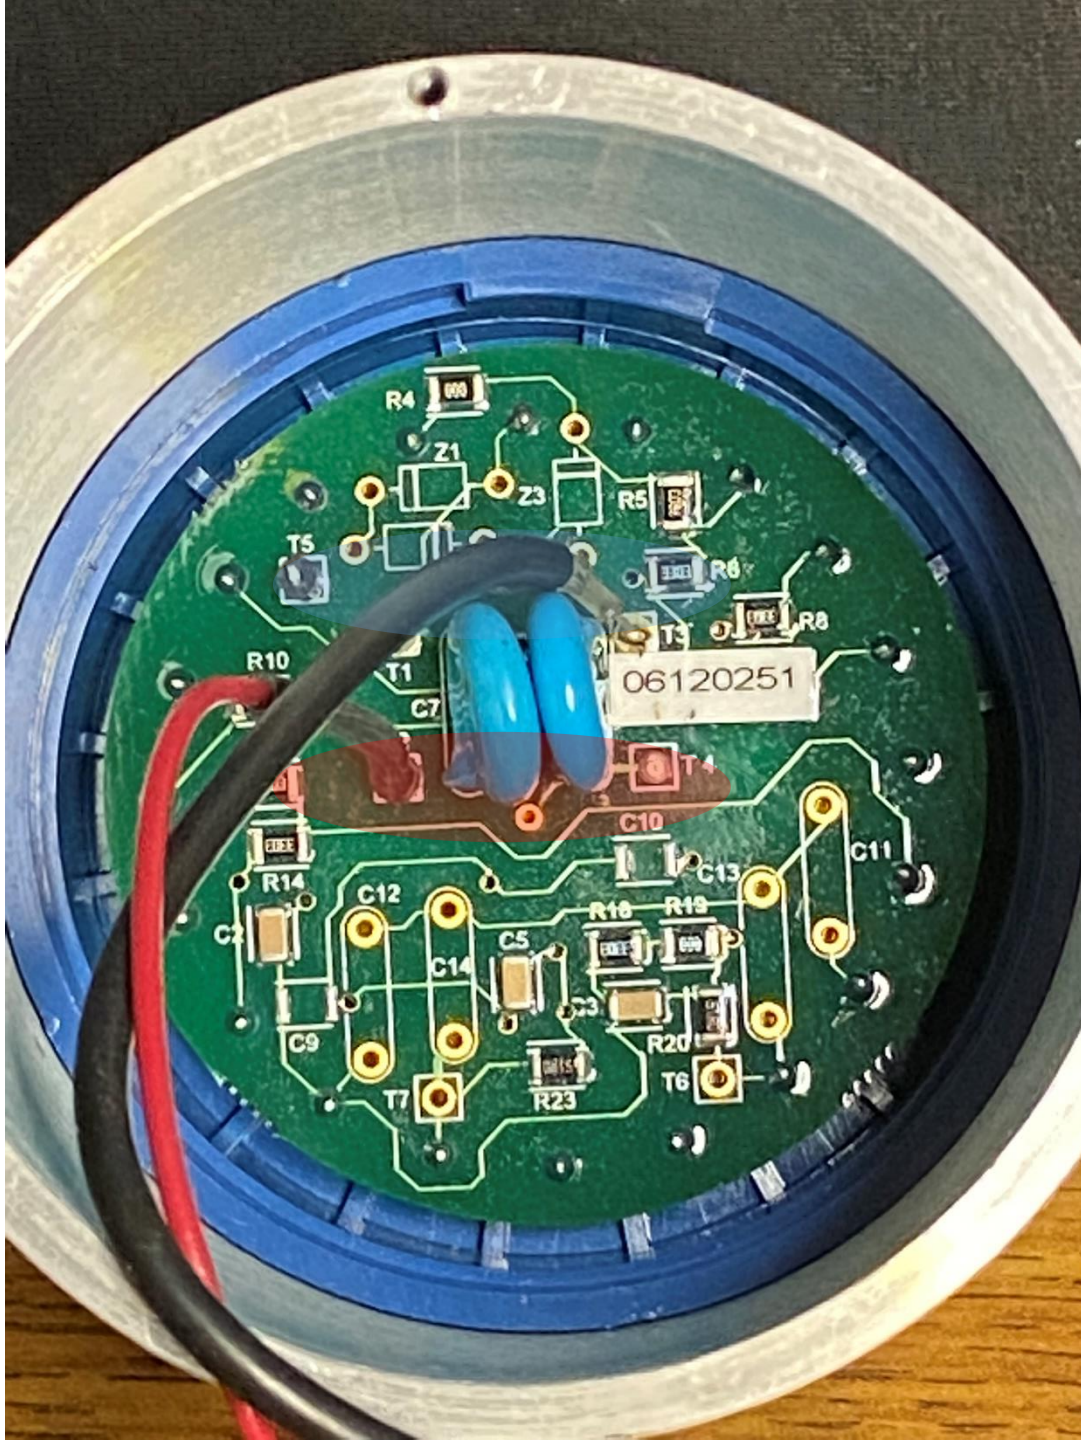
Because the board is recessed in its big blue socket, the near-spikes on the periphery are ~8mm from the grounded metal casing. And they were coated after the board was stuffed.\* So I'm not too worried about these near-spikes.

\*The fine print on the circuit diagram says "The board is conformally coated with Anti-corona lacquer RS 569-313." Other wording indicates that the big blue caps were added by hand, so the blue cap legs might **not** be coated.

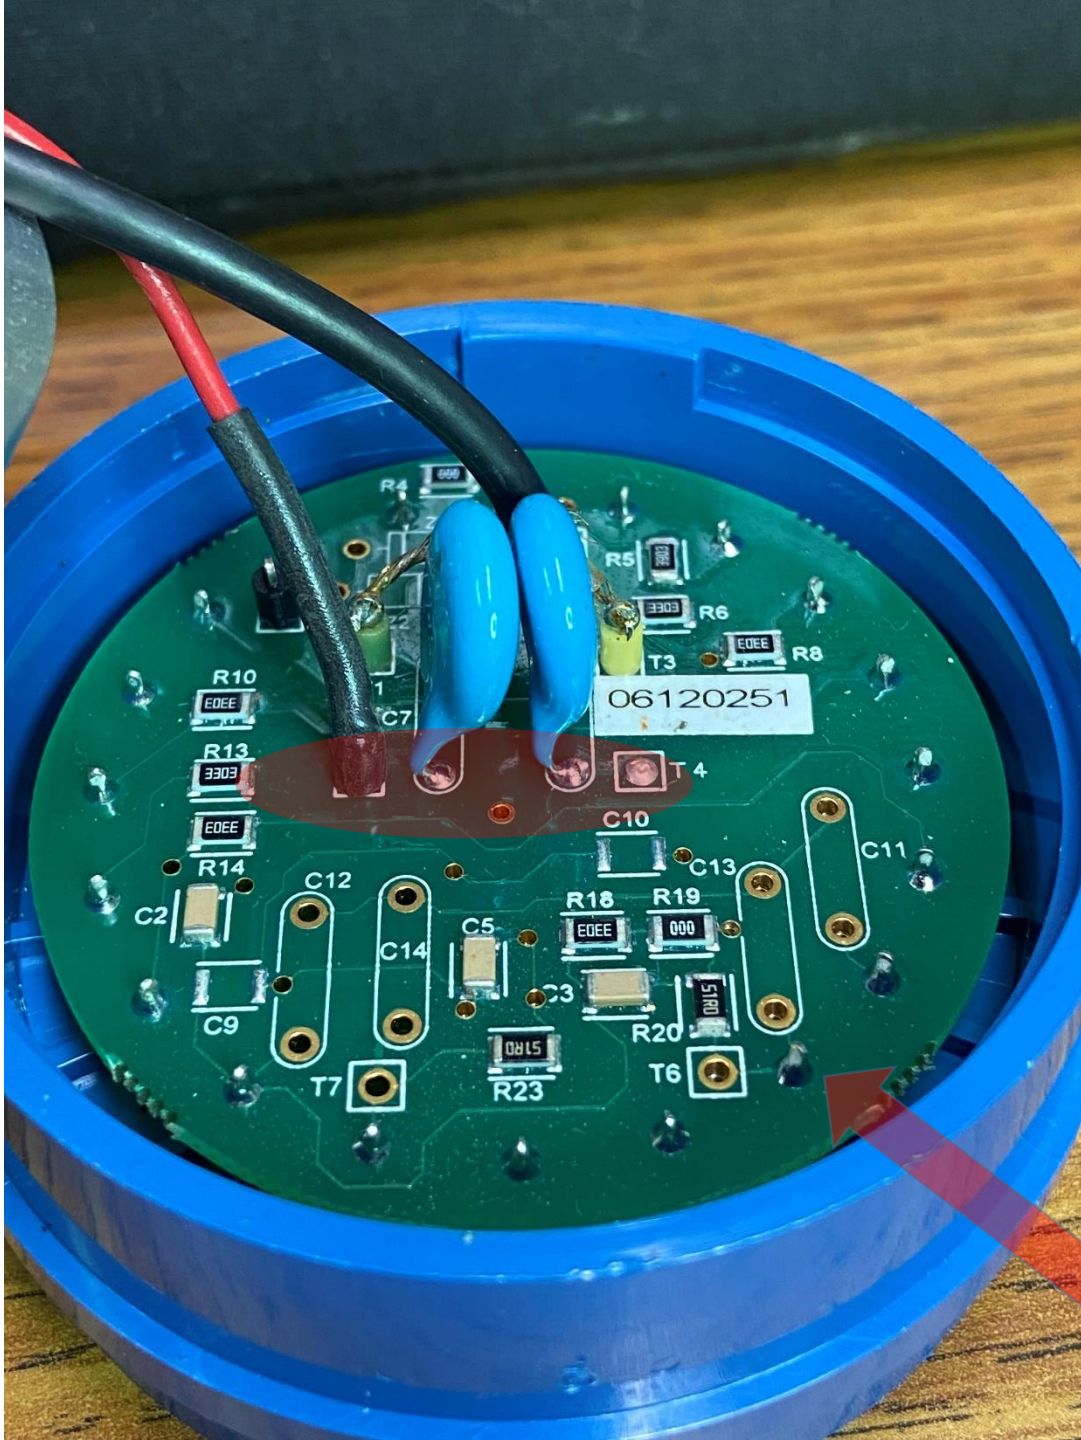
The HV cable (red) is gorgeously terminated. No worries there.

The two near-side legs of the big blue capacitors, which are in clear view, are at full +HV.

(Btw, from this oblique photo, you can better see the ~2mm height of the near-spikes on the periphery. Since higher resistor numbers mean higher potential, the biggest risk for near-spike sparking would be in the lower right corner.)

Ground is on the far-side legs of the big blue capacitors. Looks a little odd. Let's flip this around on the next slide.

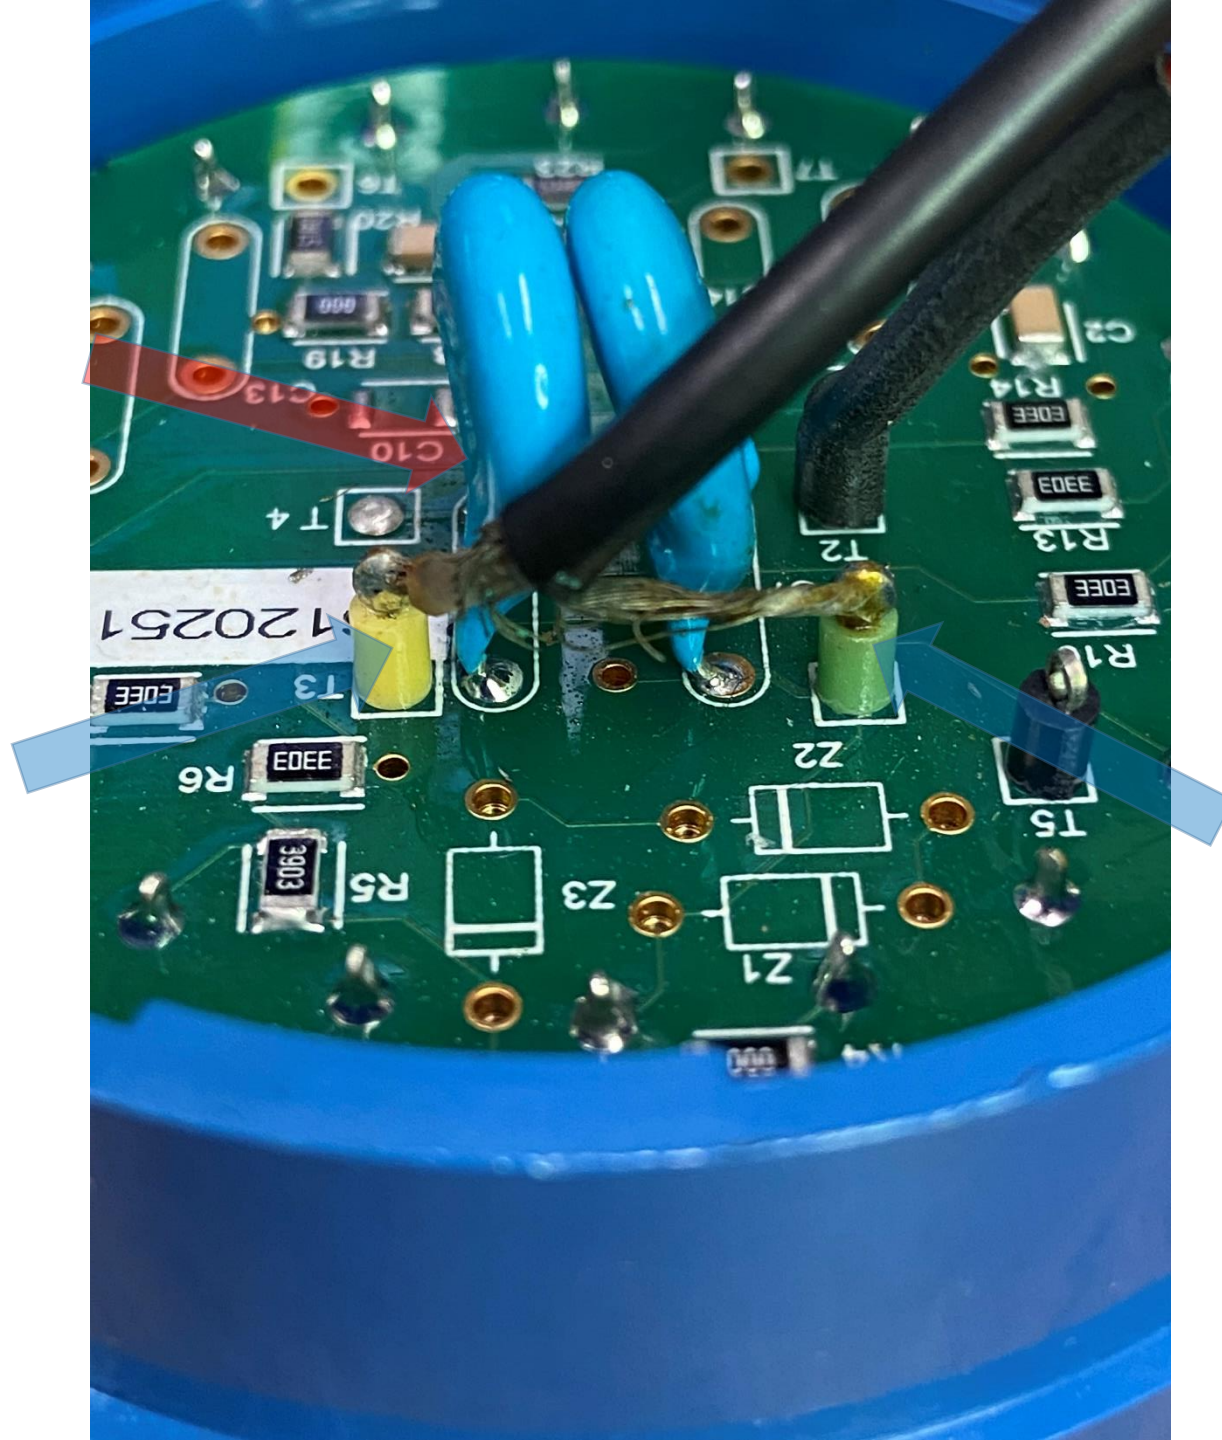
Ouch. The ground braid has a lot of wild hairs.

Not only are there sharp wire ends, but in this example some of them may reduce the gap size from 8mm to 6mm.

However, examination of the spare base indicates a workmanship issue on the signal and ground attachments. Those all need to be checked and redone as needed. There is a chance that a stray whisker from a ground braid is significantly reducing the 8mm gap in some of the bases.

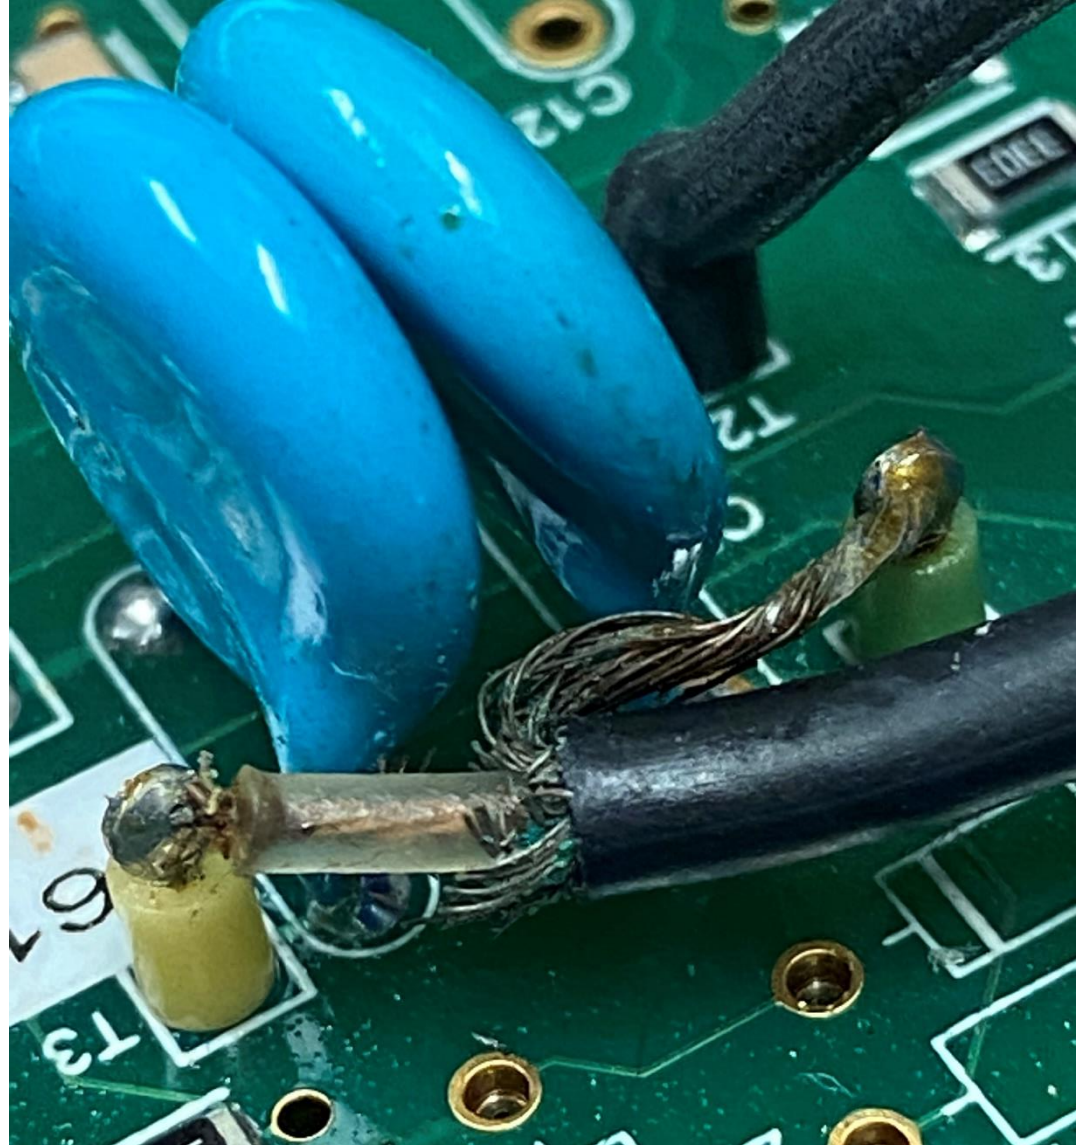
In a brief test at 2300V in air, I could not make this base spark. That's expected, since an air gap would have to drop to only ~2mm to start sparking infrequently.

But these stray ground braid wires are the kind of variable that could cause some bases to have less than 4mm gap and maybe start sparking in a Neon-rich atmosphere.

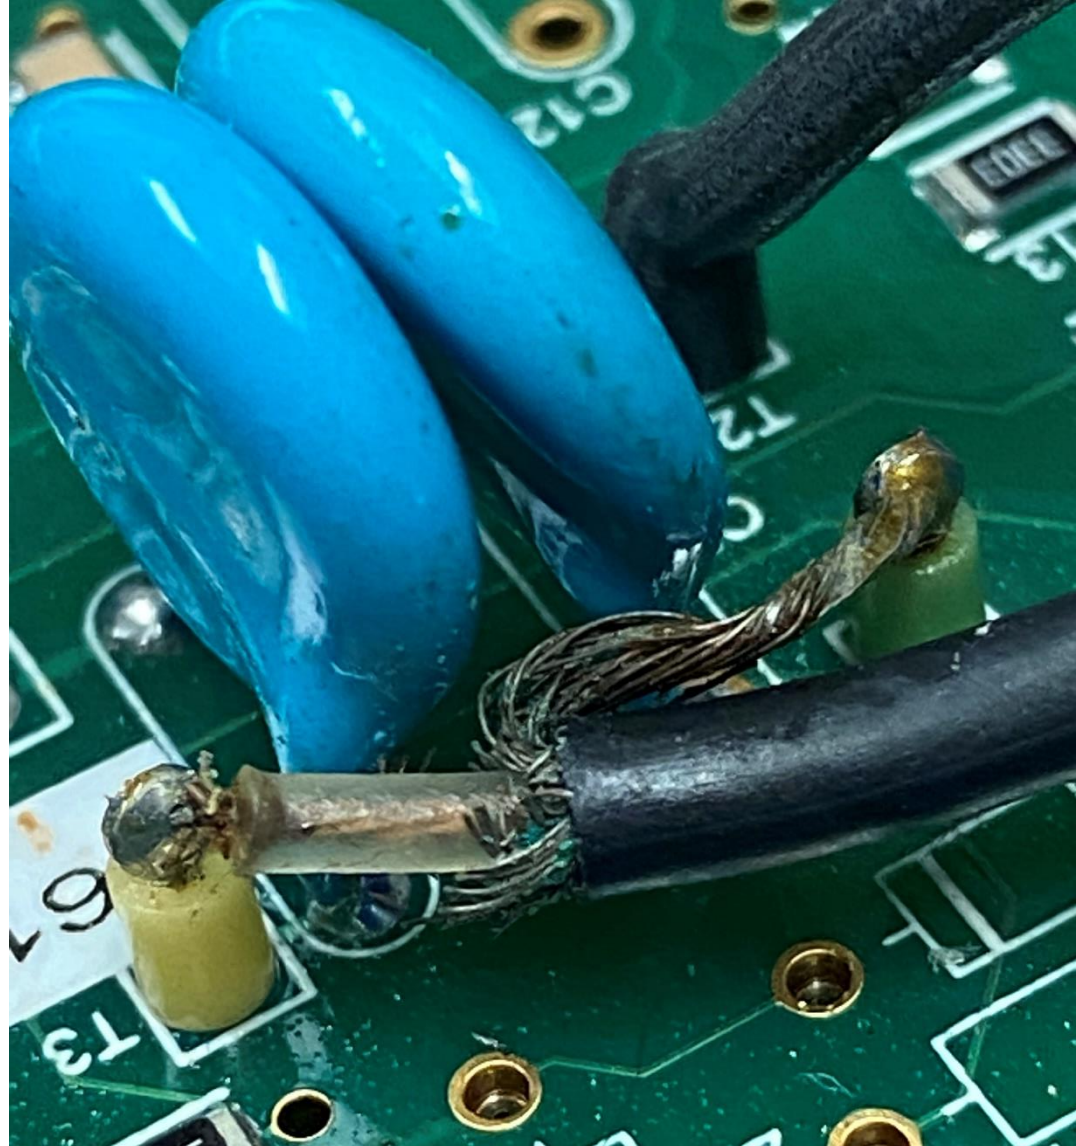
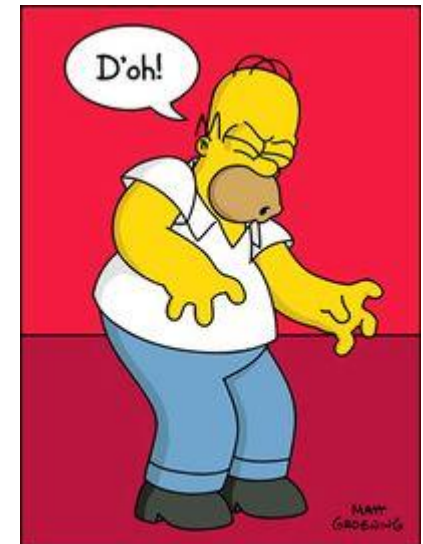
(in hindsight, to get this shot, I'm all but breaking off the signal connection)

In a brief test at 2300V in air, I could not make this base spark. That's expected, since an air gap would have to drop to only ~2mm to start sparking infrequently.

But these stray ground braid wires are the kind of variable that could cause some bases to have less than 4mm gap and maybe start sparking in a Neon-rich atmosphere.

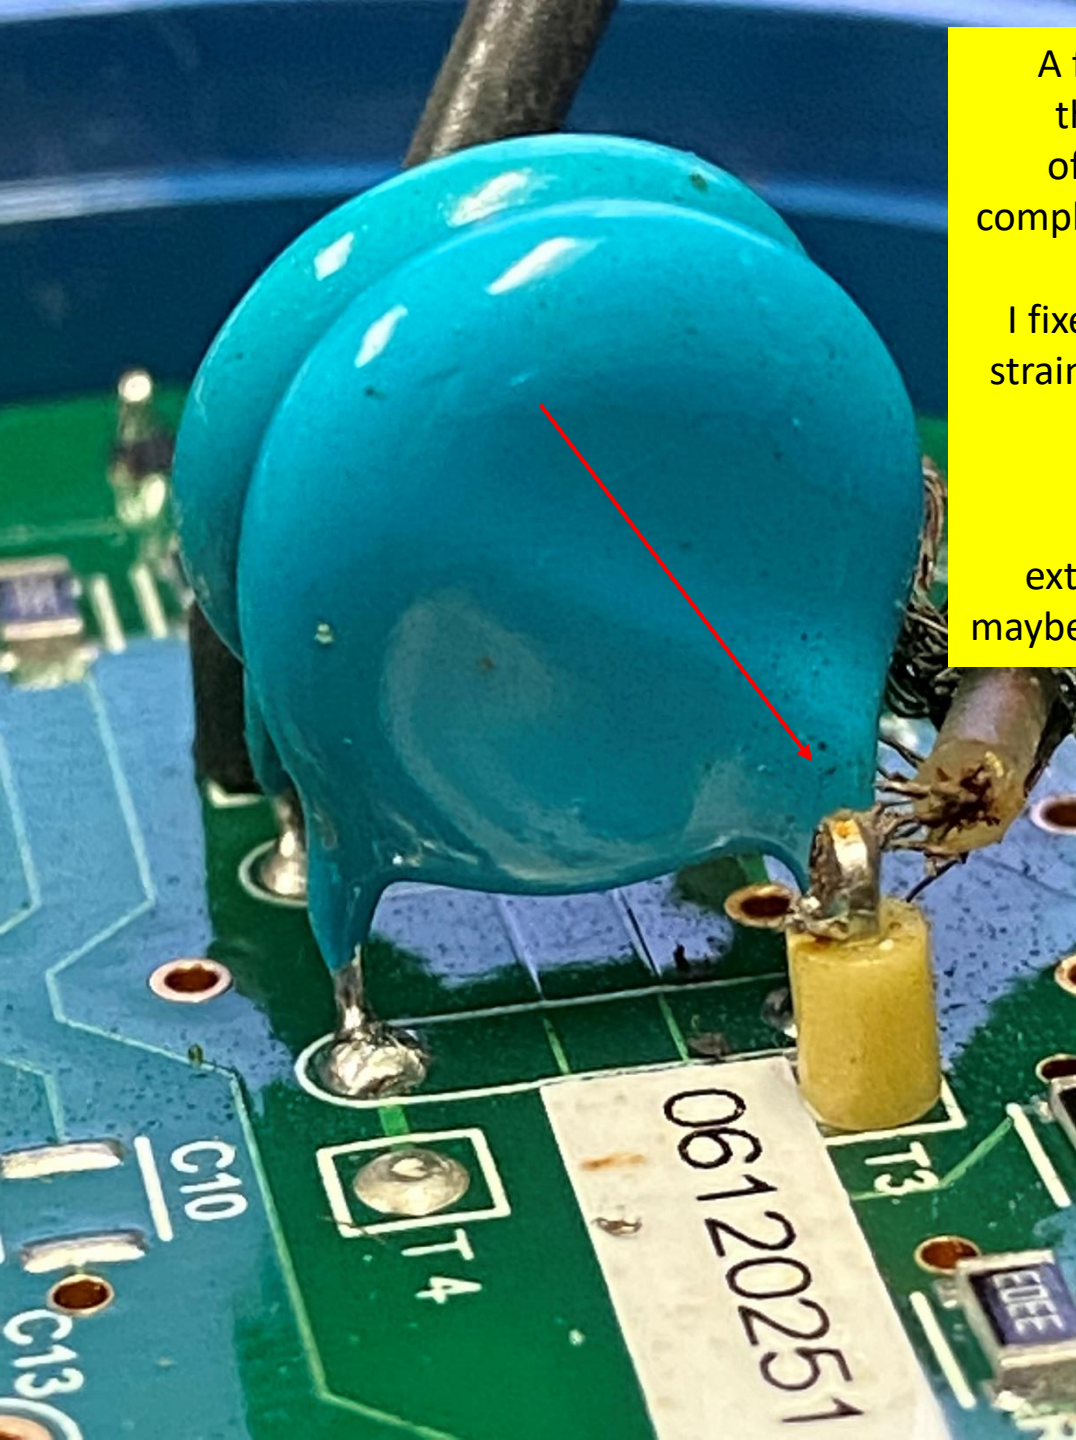
A few cable wiggles later, the few copper strands of the signal connection completely broke from the post.

I fixed it, arguably with more strain relief and fewer, shorter, sharp wire points.

(The black cable is extremely difficult to strip, maybe because it's rated for HV.)

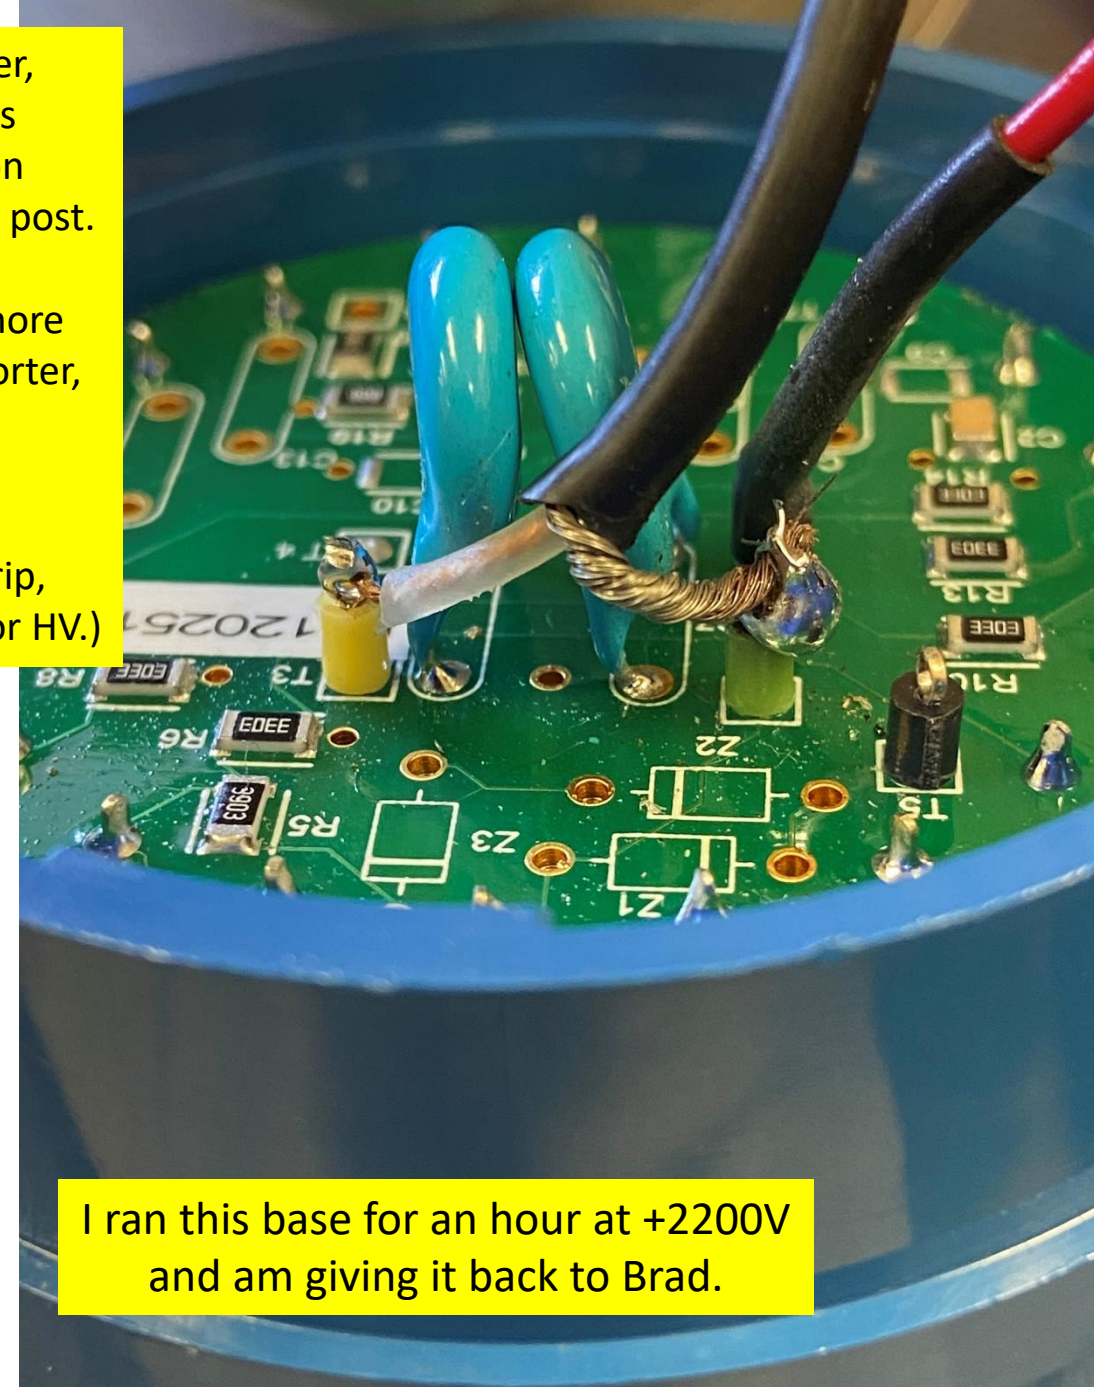
I ran this base for an hour at +2200V and am giving it back to Brad.
