SANE Polarized Target Magnet Failure

- Experiment Summary:
 - **E07-003** (Spin Asymmetries of the Nucleon Experiment-**SANE**) uses CEBAF polarized beam and a **polarized target** to measure nucleon spin structures
- Polarized Target:
 - Helmholtz pair superconducting magnet of NbTi wire (Oxford Instruments)
 - operates at up to 5.1 T (79 A); 1×10^{-4} uniformity in $3 \times 3 \times 3 \text{ cm}^3$ volume; persistent to 5×10^{-8} per hour

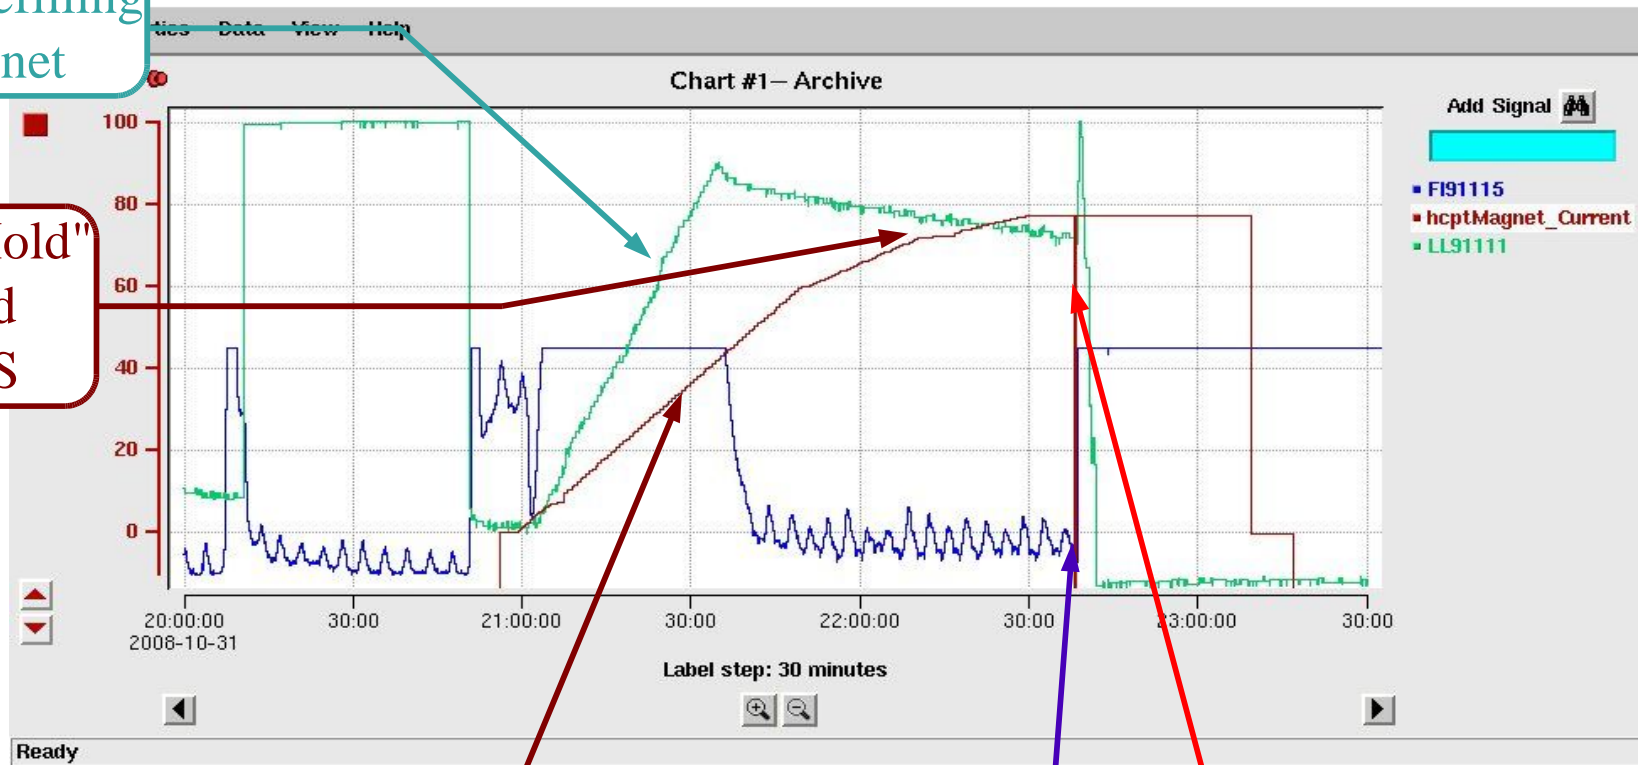
Quench of 10/31/08

- **Oct. 31st**: target magnet was energized for the first time in Hall C
 - After a few minutes at 77.3 A (= 5 T) the attempt to put the magnet in persistent mode resulted in a quench. A communication error delayed sending the signal to turn off the heater of the persistent switch while a timer was counting down 30 s to let the operator know it was ready to start running down the power supply (at 20 A/min). Ramp down started after only 13 s while the switch was still open.

Magnet energized
at three rates:
1.2 A/min to 60 A
0.6 A/min to 72 A
0.3 A/min to 78 A

He boil-off jumps
at time of quench
(vertical scale
not selected on plot)

Attempt to go to
persistent mode
before switch ready
causes quench

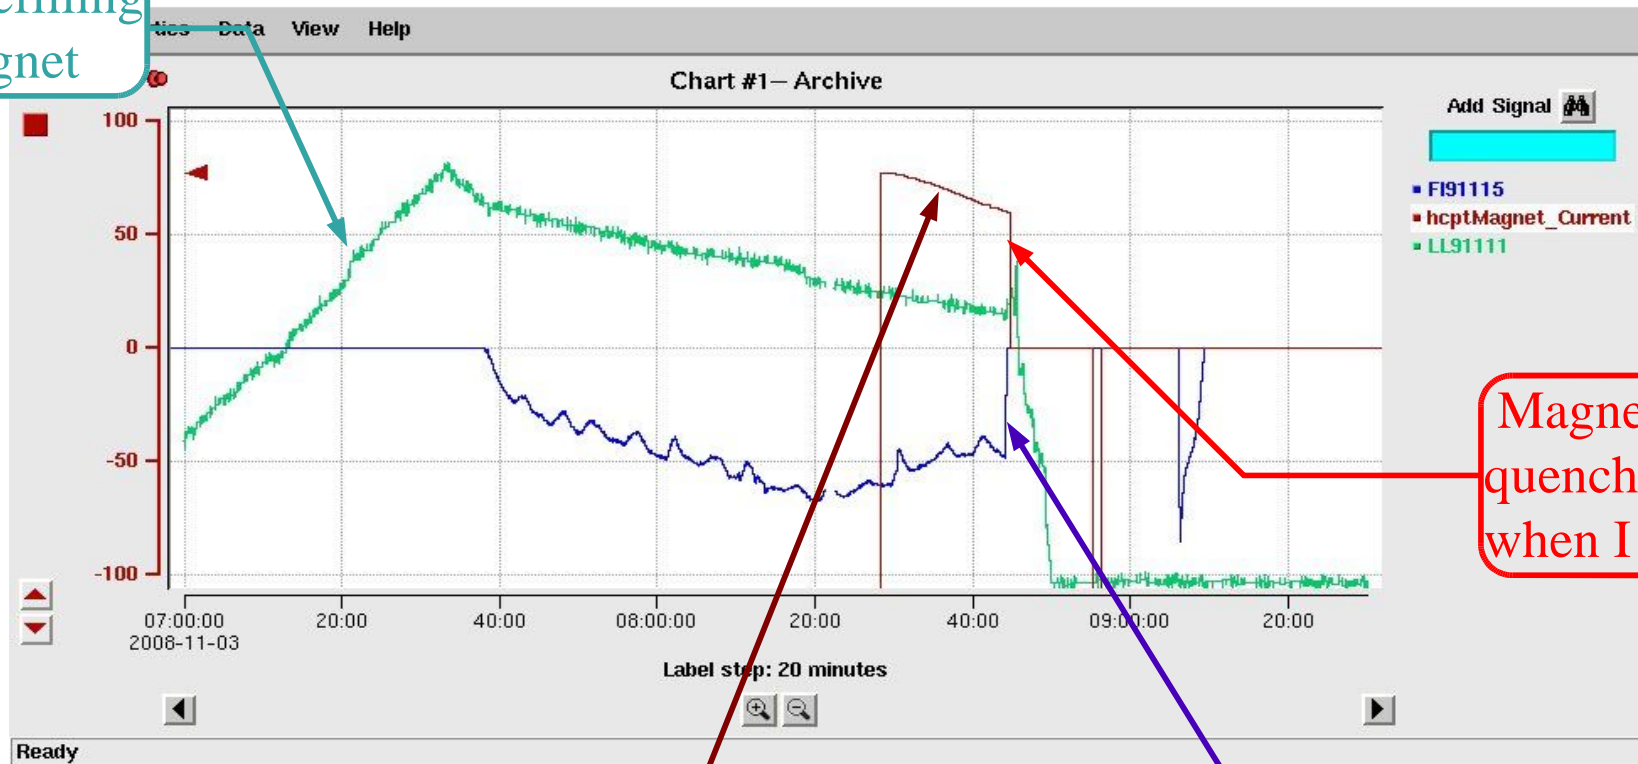
Quench of 11/3/08 AM

- **Nov. 1st**: magnet successfully energized. *e-p* calibration data taken until 11/3/08.
- **Nov. 3, AM**: magnet de-energized for polarity change (positive to negative). Quenched when current ramp down rate under PS control increased to 2 A/min, which is PS firmware's maximum rate when current is less than 60 A. PS firmware ignored 20A/min ramp rate requests by operator.

Magnet
quenches
when $I < 60$ A

Magnet de-energized
at three rates:
1 A/min to 72 A
1.5 A/min to 60 A
2 A/min to zero

He boil-off jumps
at time of quench
(vertical scale
not selected on plot)

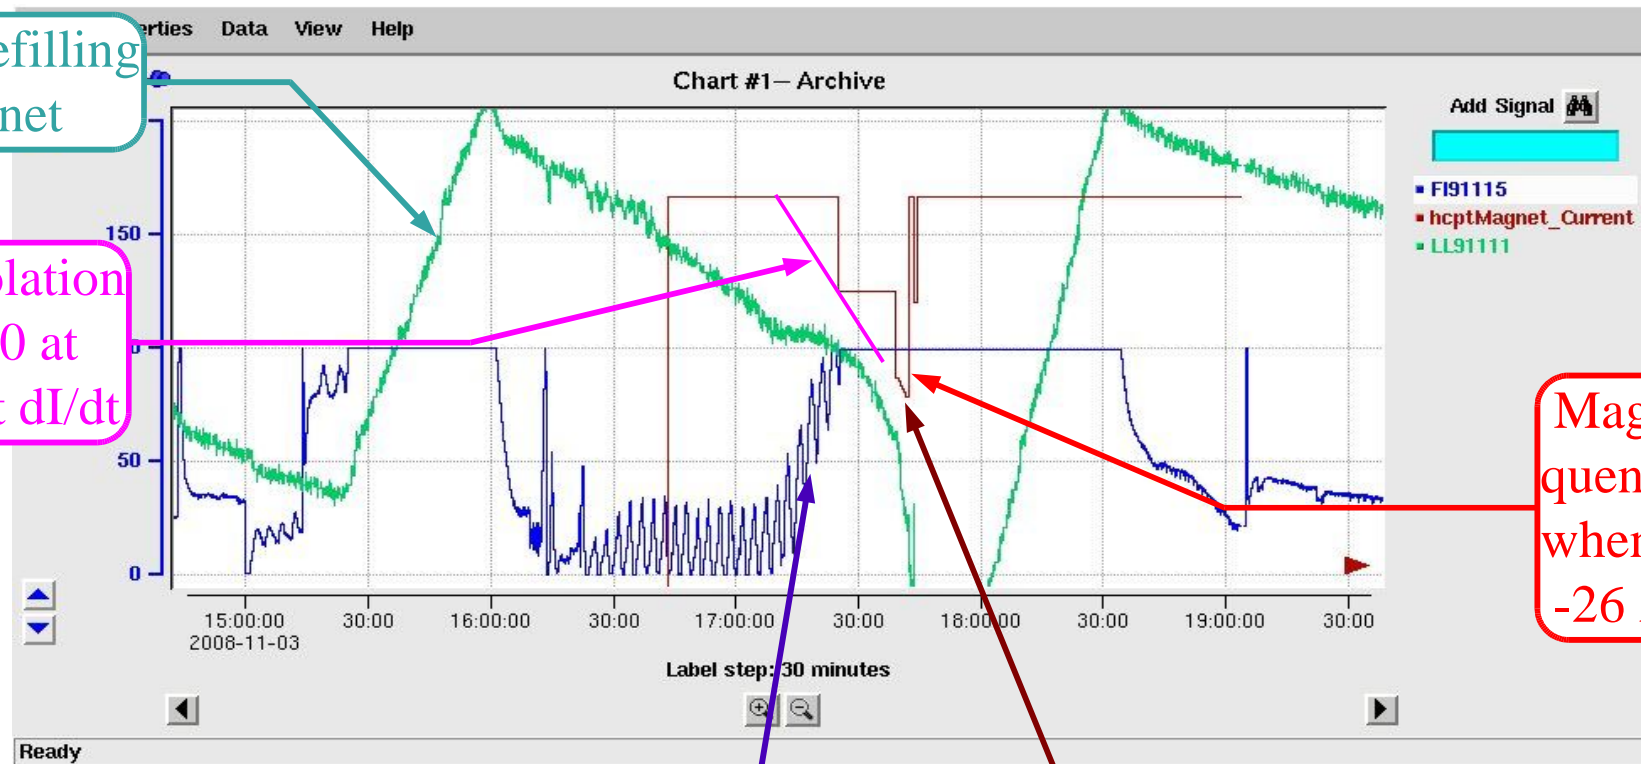
Quench of 11/3/08 PM

- **Nov. 3, PM**: magnet failed to re-energize in negative polarity after quenching at -26A. It was impossible to re-energize magnet afterwards.

Extrapolation
to $I = 0$ at
constant dI/dt

Magnet
quenches
when $I \sim$
-26 A

He boil-off increases
as current increases
Parts of magnet circuits
may not be superconducting

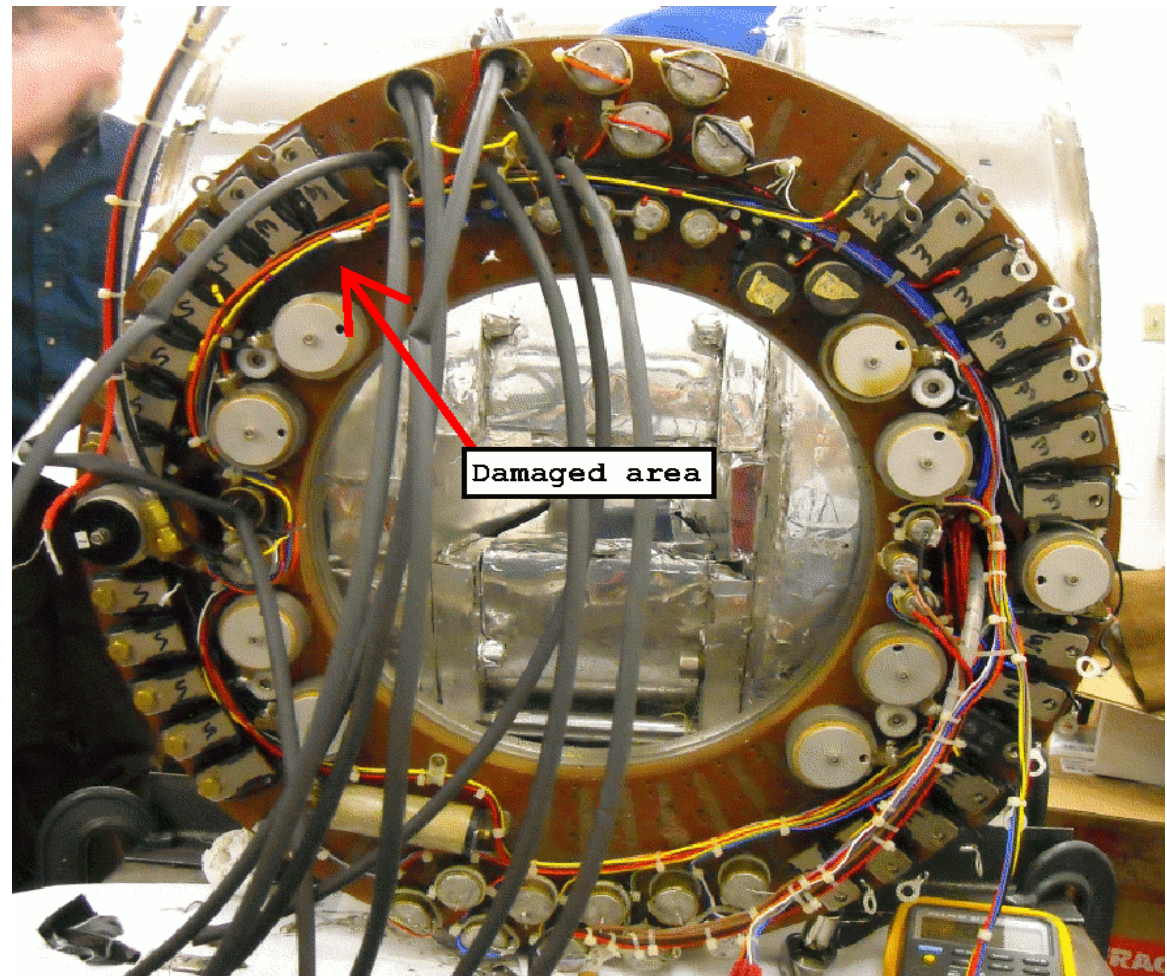
Magnet Circuit Damage

- Diagnostics with the magnet cold indicated need to open it for repair
- Extensive tests (B. Vulcan, J. Beaufait and others) led to finding of multiple burned out wires connecting sections of one of the main coils
- A protection diode for one coil was also found to be broken. It may have failed during the quench of 10/31 or in the earlier one in the Summer

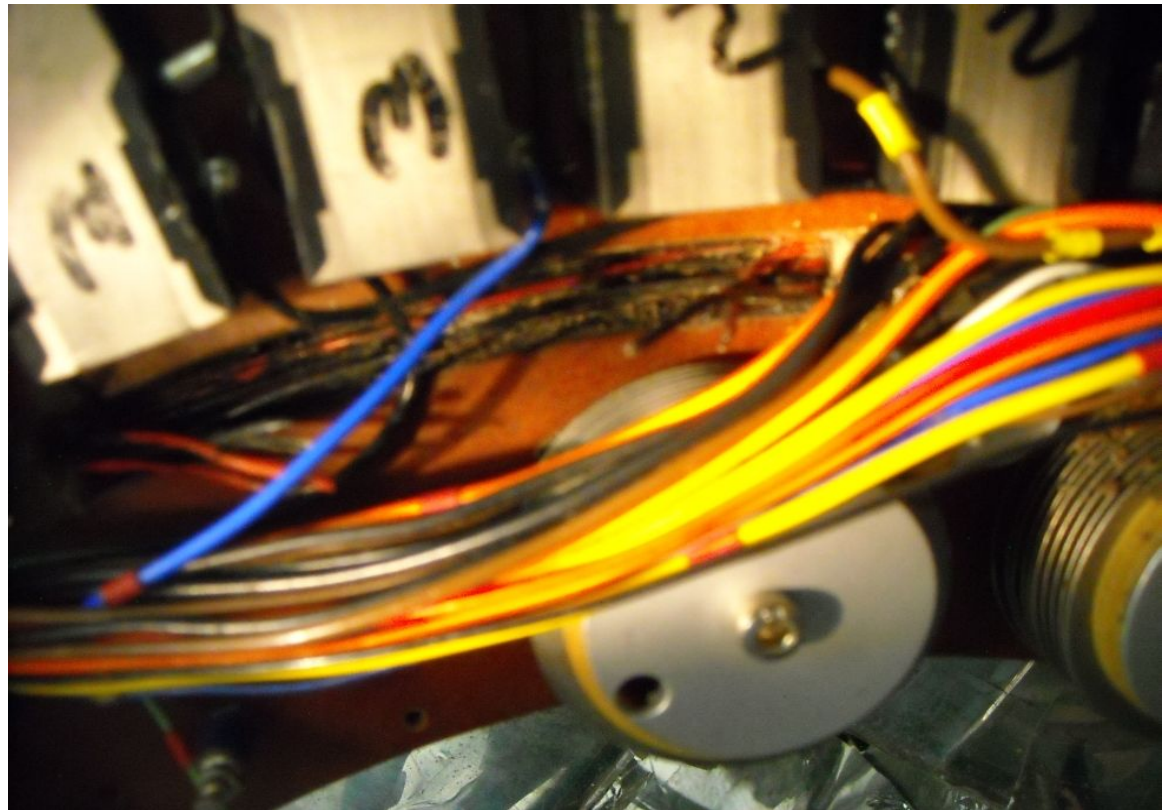
Magnet Circuit Damage

- Diagnostics with the magnet cold indicated need to open it for repair
- Extensive tests (B. Vulcan, J. Beaufait and others) led to finding of multiple burned out wires connecting sections of one of the main coils
- A protection diode for one coil was also found to be broken. It may have failed during the quench of 10/31 or in the earlier one in the Summer
