Report on the polarized target failure

Brief Description of UVa polarized target

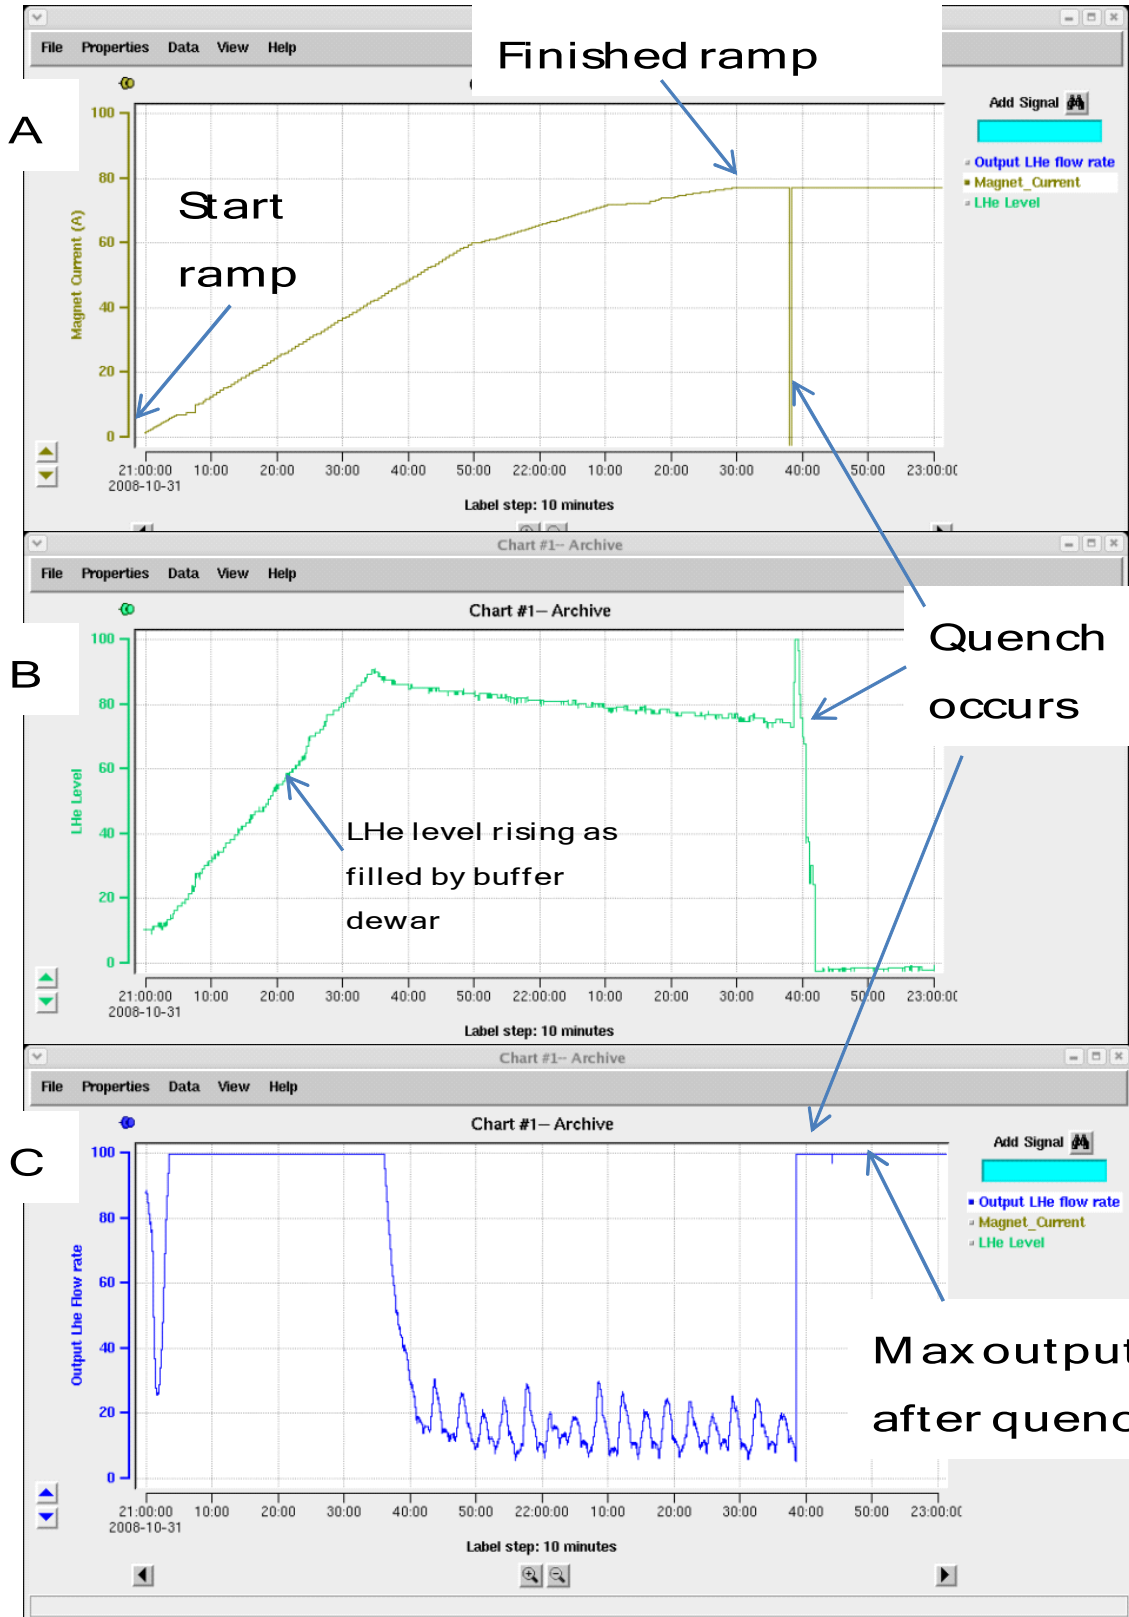
Figure 4 Strip charts of A) magnet current B) Liquid helium level and C) LHe output flow rate during quench on Oct 31st.

The first attempt to ramp the magnet to full current was on the evening of Friday October 31st. The magnet was ramped in positive polarity to full current using the “First run” rates given in Table 1. The magnet was switched to persistent mode by turning off the heater to the switch and when the magnet power supply was ramped down the magnet quenched. Looking the log file, it was found that heater had been turned off for only 13 seconds before the power supply leads were ramped down. This means that the persistent switch had not gone superconducting, and this caused the quench. There is a timer which counts down 30 seconds to tell the target operator when to start ramping down the current in the leads, but there was communication error which delayed sending the signal to turn off the heater while the counter on the computer was counting down.

In Fig. 4 is a chart showing the power supply current (4A), the liquid helium level of the magnet (4B) and the liquid helium output flow or boil-off (4C). The level meter for the LHe is located about 1-2 inches above the bottom on the helium tank. Therefore when the LHe level reads 10%, there still is liquid helium in the magnet. Looking the LHe liquid level (shown in Fig. 4B) , a batch fill of the magnet dewar starts just as the magnet is being ramped which results in a rising LHe level. As a result of the batch fill, the output LHe flow is at 100 (see Fig4C) . The fill is completed at 21:40. The LHe flow drops back down to its normal level and the LHe level slowly drops while the magnet continues to ramp. This indicates that the magnet is superconducting. Magnet quenches at about 22:40. The flow pegs as a result. The level jumps to 100% (this behavior is due to pressure increase during quench) and then drops to 0%.

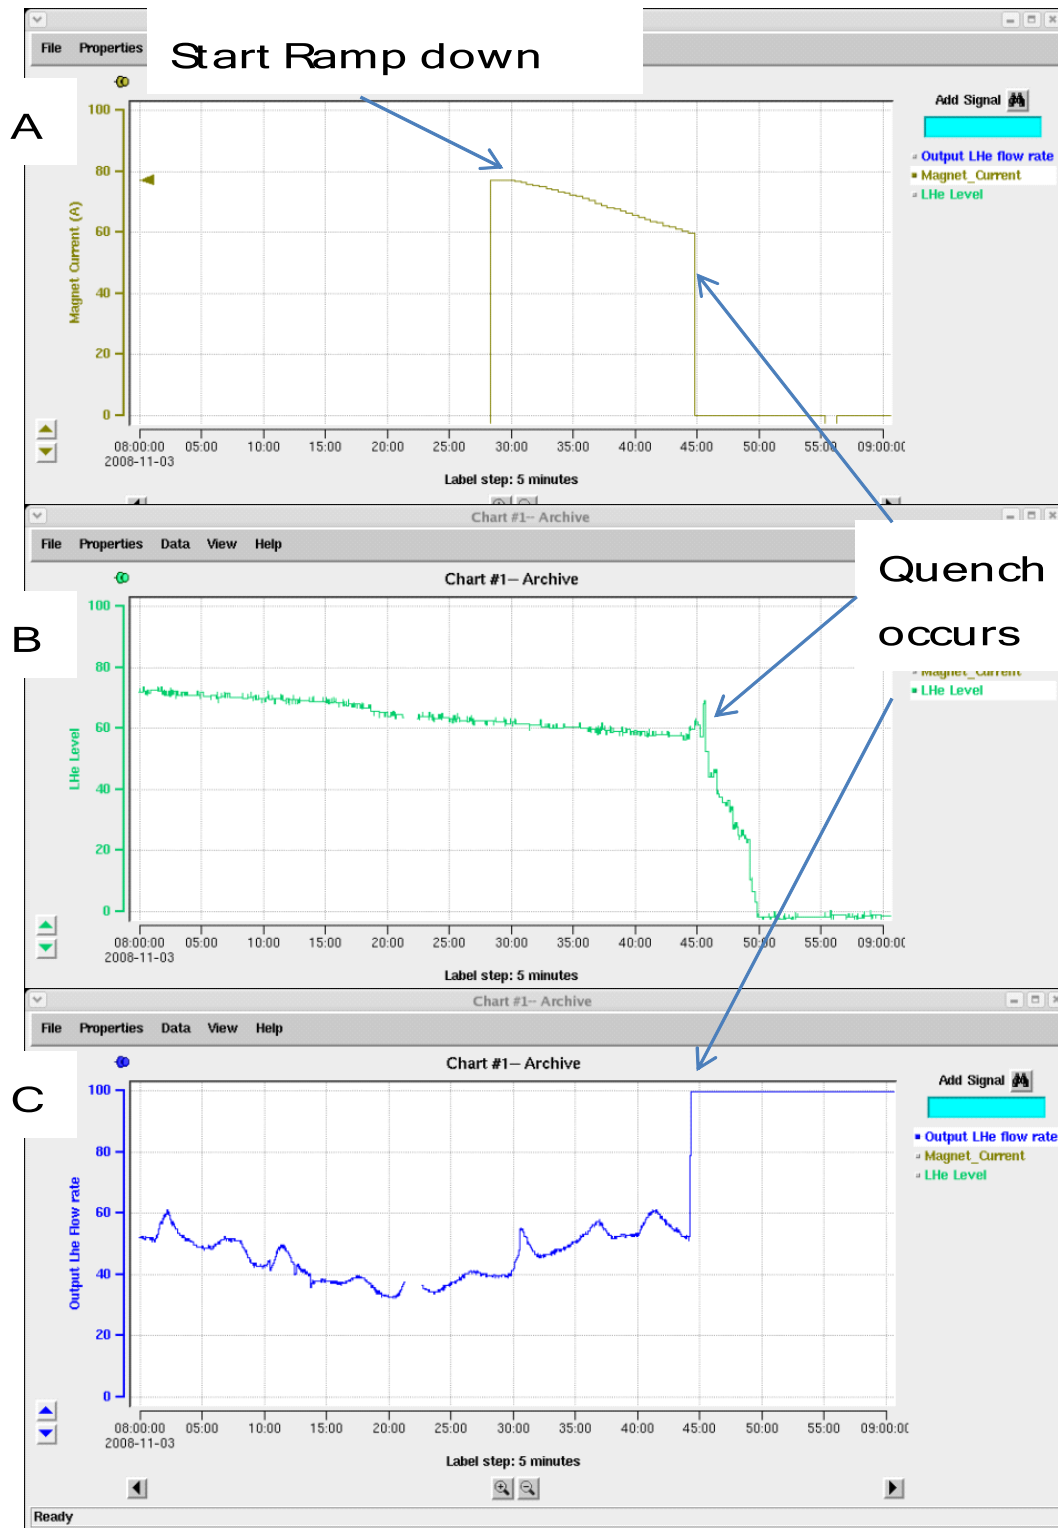
Figure 5 Strip charts of A) magnet current B) Liquid helium level and C) LHe output flow rate during quench on Nov 1st at 8am.

On Monday Nov 3rd at around 08:30am, the SANE experiment was planning on switching the polarity of the polarized target magnet. To do this the magnet first needed to be ramped down. In the process of this ramp down the magnet quenched. Though the target operator was familiar with polarized targets, this was the first time that the target operator had ramped down this particular magnet. The target operator (by entering data into the LabView control program) attempted to ramp down the magnet at 20A/min. The top panel for Figure 5 shows the current versus time for the quench. One can see that the actual ramp rate started out as 1.0A/min as programmed into the power supply. When the current dropped below 72A the ramp rate changed to 1.5A/min. The fact that the target operator was trying to ramp the magnet at a faster rate was ignored by the power supply. The magnet quenched when going below 60 amps and the ramp rate was increased to 2A/min.

Fig. 5 shows the liquid helium level in the magnet in the middle panel B and the LHe output flow rate or boil-off in the bottom panel C. A slow drop in LHe flow and level is seen before the heater to the persistent switch is turned on and the ramping down of the magnet began. The magnet was at +77 amps when it was taken out of persistent mode at 8:27. Note that flow increases slightly (due to current in magnet leads and persistent switch heater), but is still reasonable. The magnet coils are still superconducting. The magnet quenches at 60 amp (08:45), immediately followed by a liquid level spike and a drop, and the LHe boil-off flow pegs at 100.

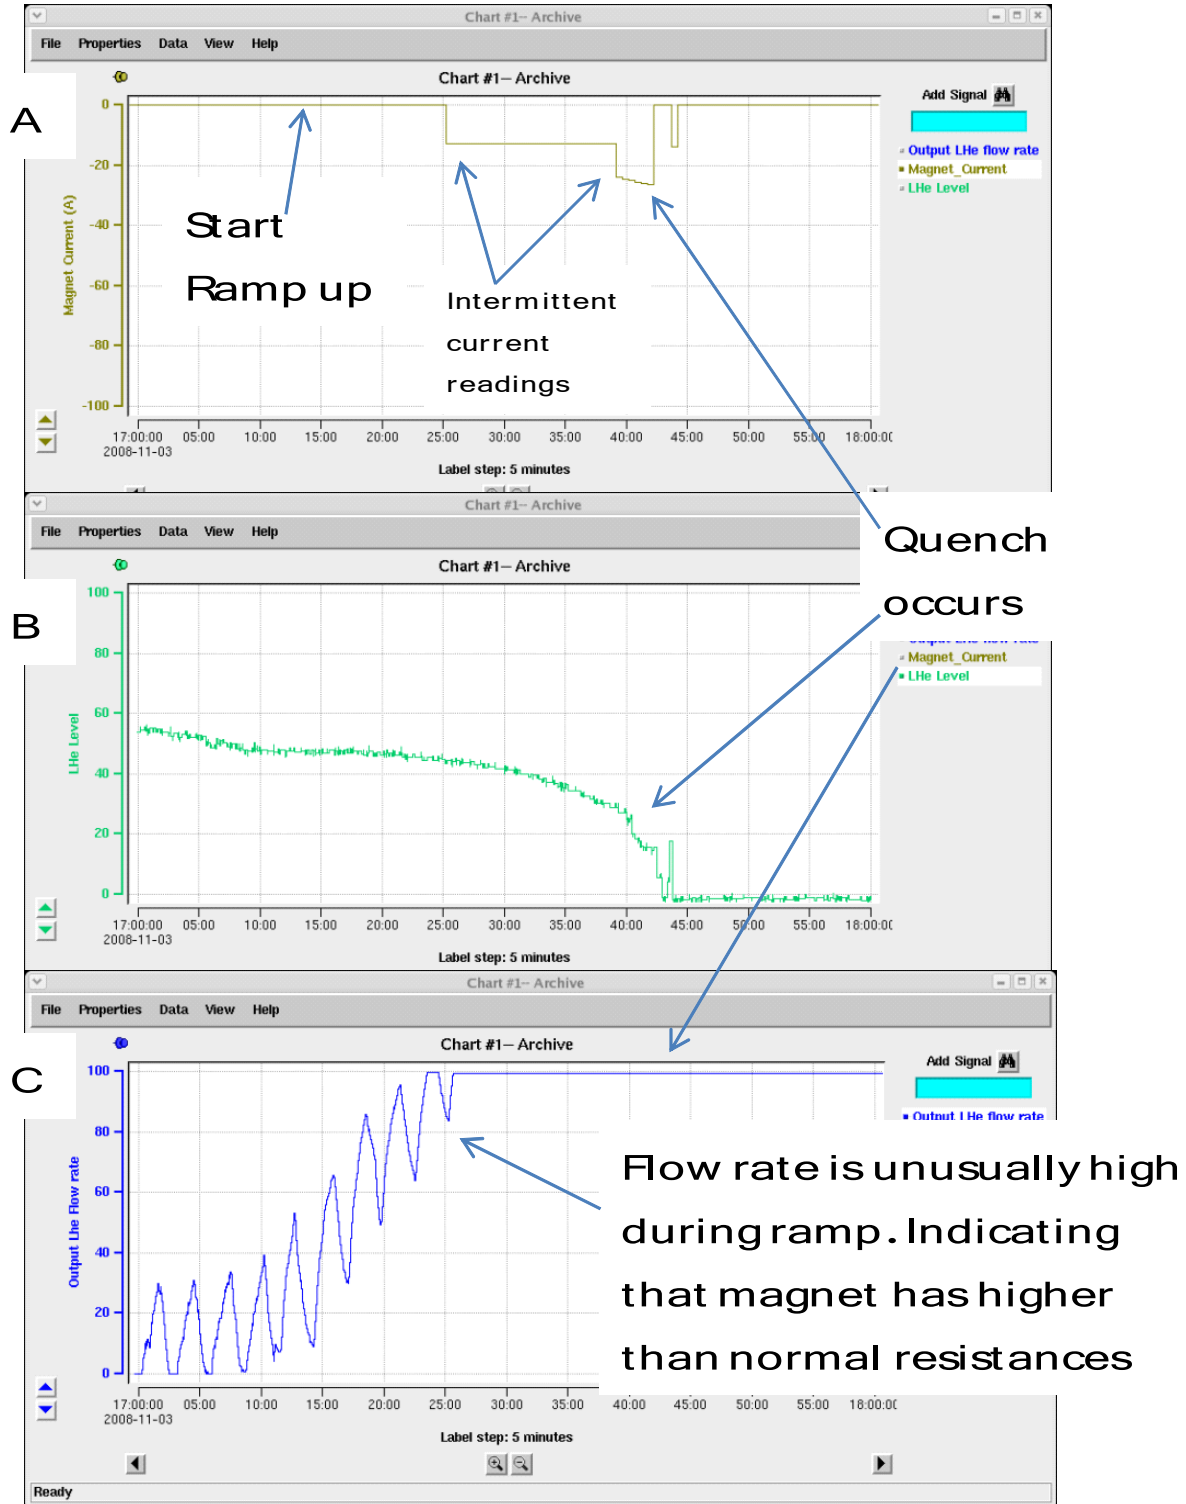
Figure 6 Strip charts of A) magnet current B) Liquid helium level and C) LHe output flow rate during quench on Nov 1st at 5pm.

The magnet was cooled down during the rest of day on Monday. Around 5pm, an attempt to ramp up the magnet in negative polarity was made, but the magnet quenched at 26A. In Fig.6, a chart shows the power supply current (top panel A), liquid helium level of the magnet (middle panel B) and the liquid helium output flow (bottom panel C) during this quench. Unfortunately the reading of the magnet current was intermittent at the beginning of the ramp so it is hard to see exactly when the ramping started. One point to note is that the magnet is ramping in negative polarity which is indicated by a negative current. By extrapolating back, the approximate start of the ramp is indicated in the top panel of Fig.6 at about 17:10. There are current measurements of -12 amps at 17:25, and -23 amps at 17:38. After this reading, there is a steady reading of the current and one sees the current increasing steadily to -26.4 amps. The magnet quenches at 17:42. Looking at the LHe output flow in the bottom panel of Fig. 6, one sees that the output flow quickly rising at the magnet ramps up and is at 100 when the magnet is only at 12A. This indicates that the magnet has a higher than expected resistance and that there is a problem.

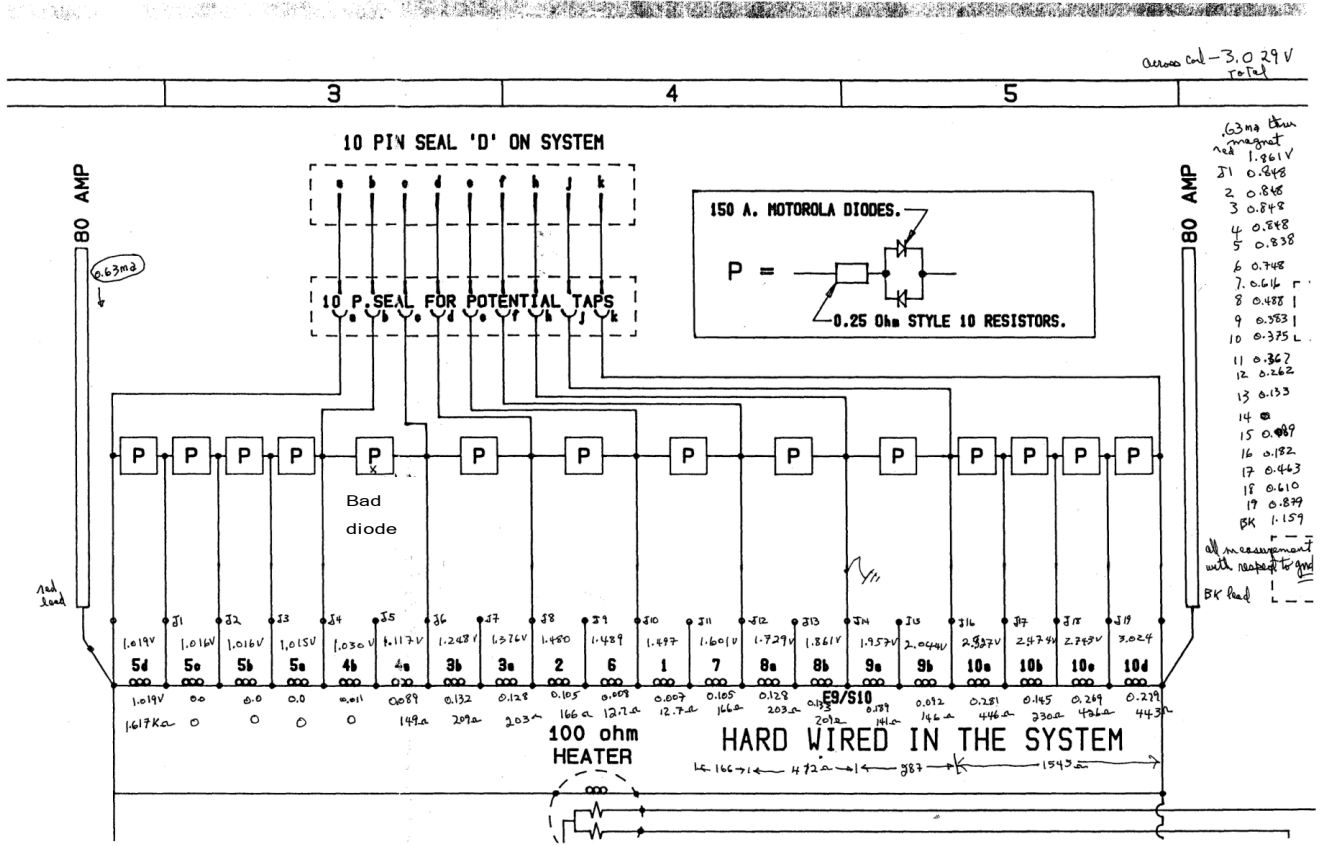
Figure 7 Circuit diagram of the magnet.

Once the target was warmed up and removed from the pivot, the magnet coil package was removed and taken out of the hall. It was taken to the EEL where the top cover of the magnet was cut off. Initial investigation found a diode that was broken, but no obvious signs of problems. The location of the broken diode is between coils 4b and 4a, as indicated in Fig. 7.

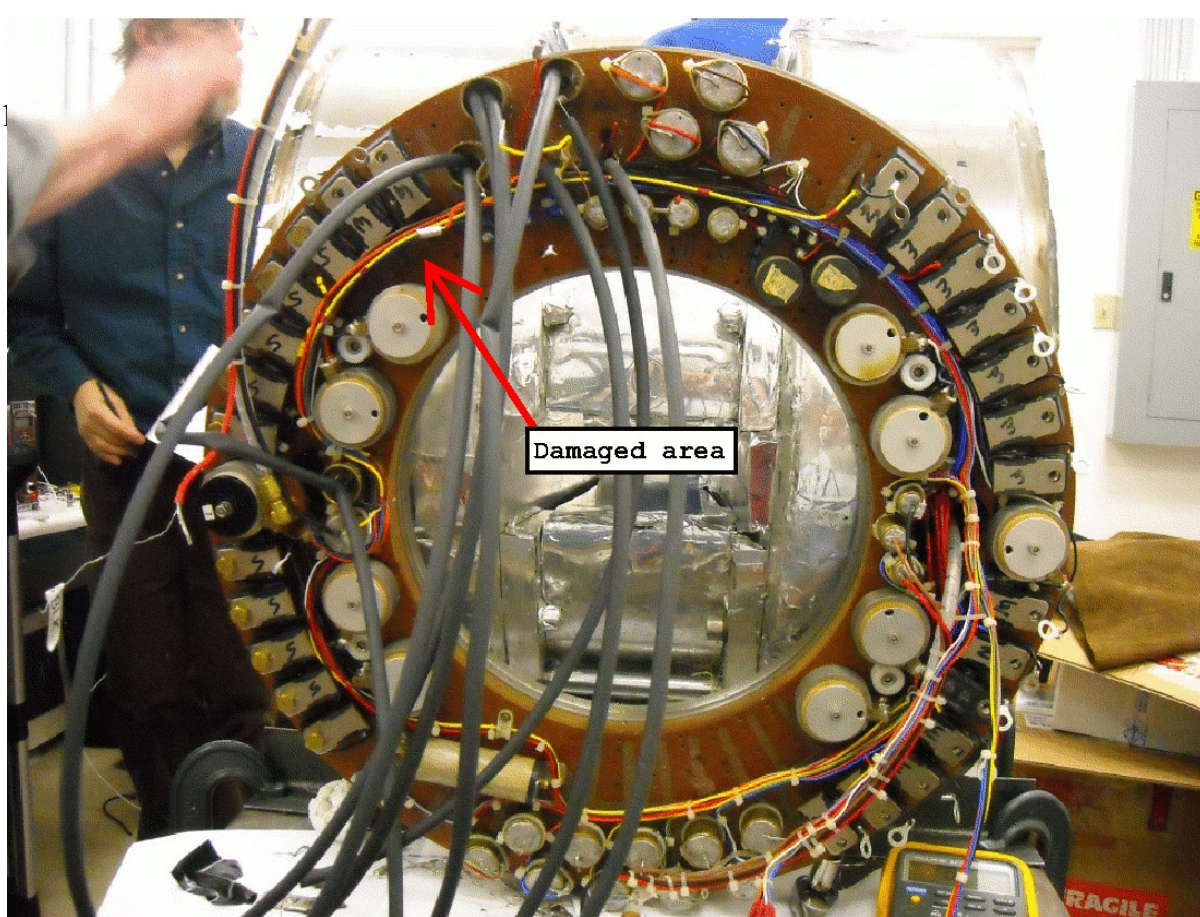
Bill Vulcan took some voltage measurements. First he disconnected the heater switch by taking out the solder from J0 and he also disconnected the diodes. He then put a source of 0.63mA through the circuit as indicated in the Fig. 8. In the Fig. 8 (above the 5d, 5c, etc) are the voltages relative to the red lead and below are the differential voltage and calculated resistance. For the one side of the magnet (coils 1, 7, 8a, 8b, 9a, 9b, 10a, 10b, 10c, 10d) the resistances agree fairly well those expected for the coils. The surprising discovery was that at J1 a resistance drop was measured which was what one expects by adding 5c+5b+5a+4b; however voltages drops across the individual J2 through J5 are zero. Bill also measured the junction points relative to ground that is the list of voltages on the right side of the Figure 8. After discussion with Oxford we decided to remove solder from joints J1 through J5 and measure the resistance of each coil individually.

Figure 8: View of magnet electronics, with area of damage pointed out.

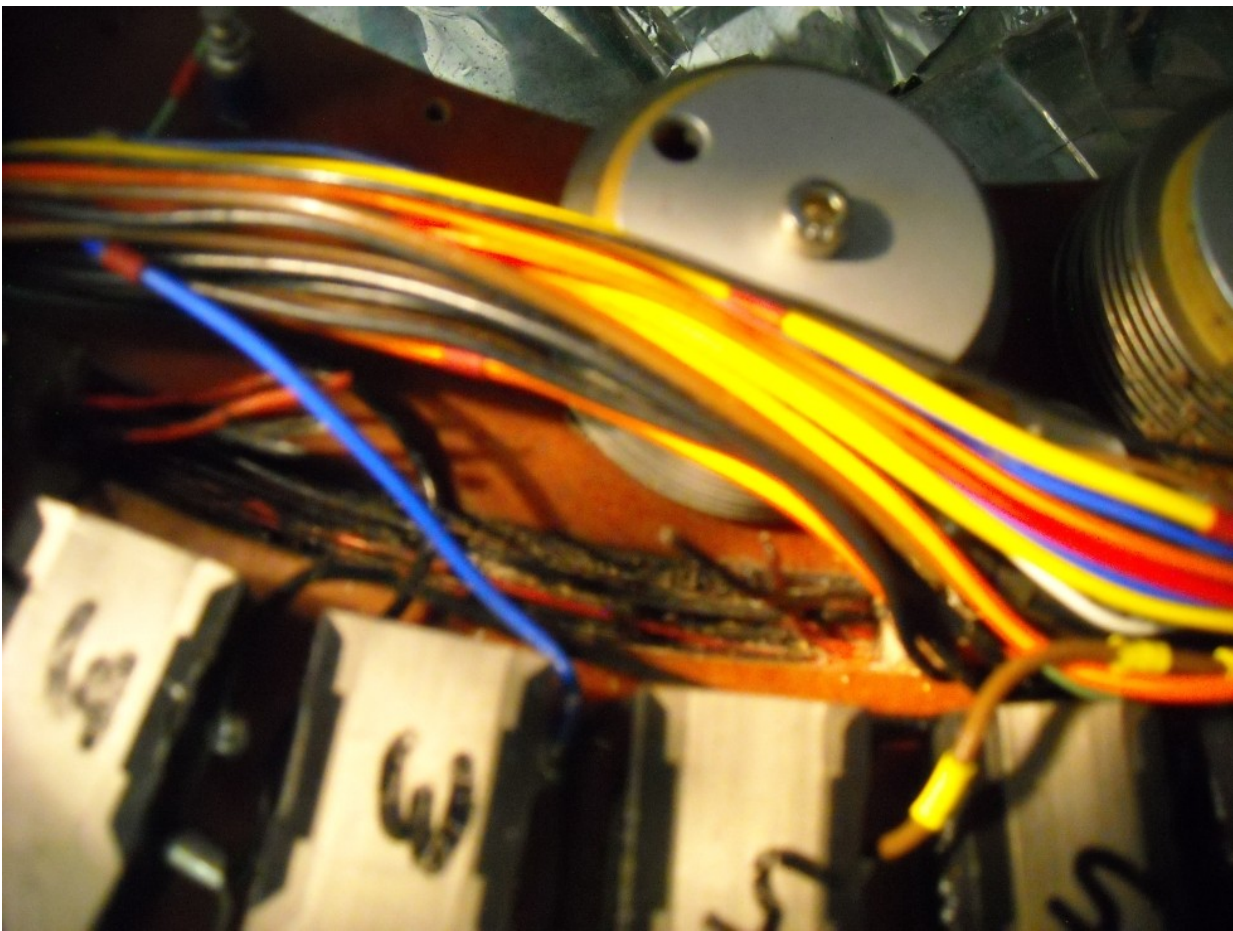
Each of the joints at J1-J5 was opened and the resistances were measured for each coil. The results were still puzzling. In contrast to the previous readings with the J1-J5 joints closed, several infinite resistances were found. While investigating a lead with infinite resistance, the superconducting wire was pulled out with only a short amount of extra cable. This indicated that the wire had broken in a location near the joint connection. The leads of coils are packed into a channel to get from the coils to the individual joint cups. In digging out the plasticene that held the wires in place damage to the wires was found. The location of the damage is shown in an overview in Figure 8. In Figure 9 is shown a close-up where damaged and/or broken wires were found. Six broken wires were found. After a systematic process of elimination that involved matching red to black (and vice-versa) leads, the 6 broken wires were identified and are listed in Table 3. Comparing the resistances between matching opposite coil found agreement at the 2% level indicating that the rest of the coil was in good shape. After consulting with Oxford, it was agreed that there was enough superconducting cable (about 4 inches) coming up through the hole that goes down to the coils to make a new joint for each damaged lead.

Figure 9: Close-up of magnet electronics, where broken and/or damaged wires were found.

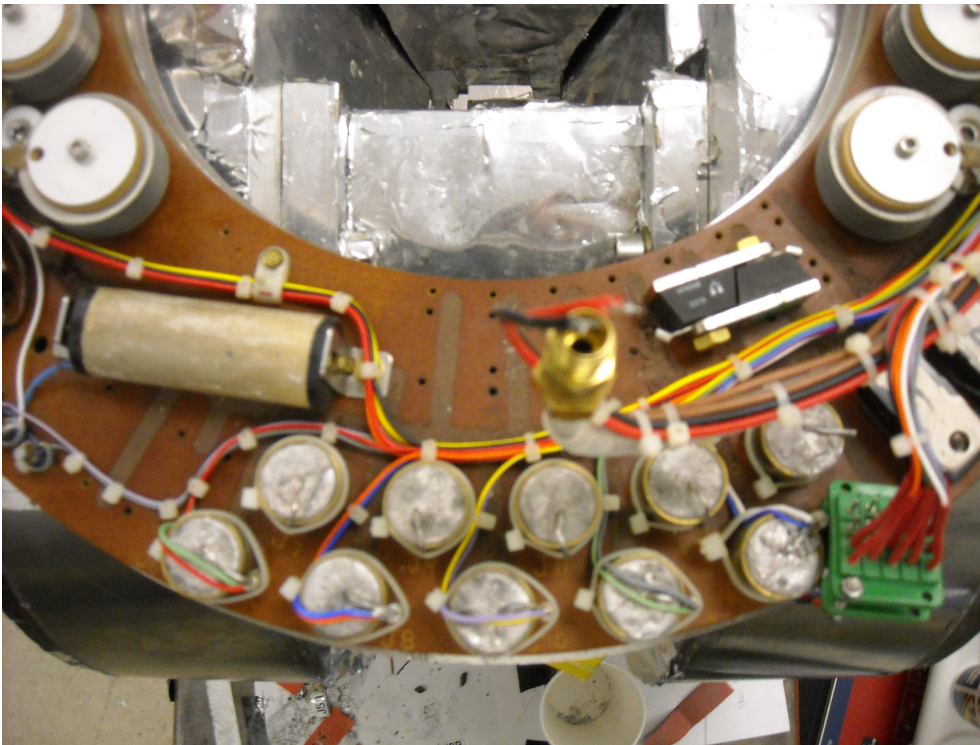
Figure 10: Picture of top of magnet showing the new diode location.

On Monday Nov 24th, Oxford engineer Paul Brodie arrived to work on repair of the magnet. Joe Beaufait and Paul Brodie worked on making new joints for the broken wires. Oxford instruments shipped extra materials for the repairs and provided instructions for making repairs. After consultation with Joe it was decided to make a superconducting joint for the first inch and then a copper to copper connection for another 3 inches. The superconducting joint was made by stripping off the copper and using an ultrasonic soldering iron (provided by Mike Seely) to make the connection. The copper to copper was a regular solder connection. After the new joints were made, the resistance was measured to check that it was the same as before. To determine the polarity of the leads, current was sent through one good coil and the direction of the field determined with a compass. Each coil was connected to the supply and the polarity of the leads was determined by matching the direction of the field to the good coil. Once the polarity of the leads was determined, the leads from nearby coils were joined together as before and put in the joint cups. Connection to the rest of the circuitry was made. The bad diode was removed. It could not be directly replaced, but a new diode was put in place (see Fig. 10) and connected into the circuit with new cables. Because the new superconducting joints are short, the magnet will not be a “high” persistent mode magnet when it is re-installed. Originally, the magnet decay was 5 parts in 10^8 /hour. This is not a problem, as the polarized target will work with poorer magnet persistence. Therefore, once installed, we will set the magnet in persistent mode and see how the magnet field decays. If the magnet is not persistent, it can be run constantly from the power supply. The current from the power supply is stable at 1.5×10^{-4} which is sufficient for the experiment.
