SHMS HGC Cerenkov PMT Sanity Checks at UVa

B. Sawatzky ([JLab](#))

D. Day, A. Conover, P. McCormick ([UVa](#))

SHMS HGC (Heavy Gas Cerenkov)

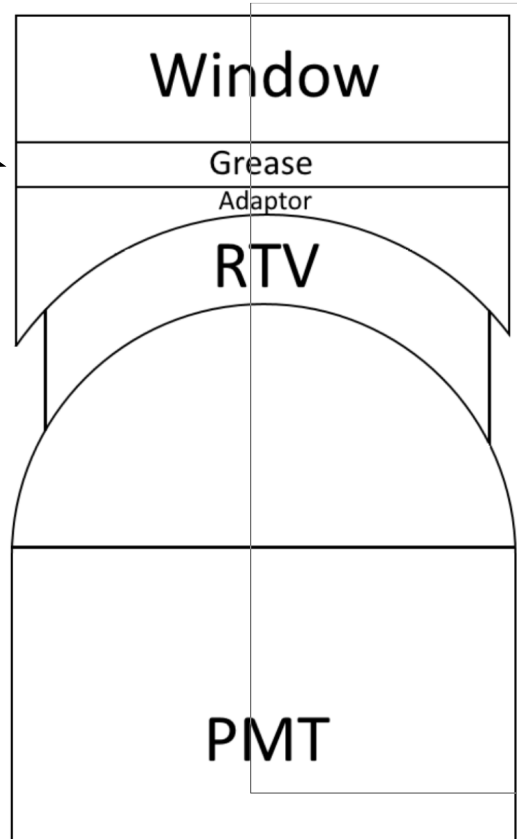
Removed from PMT1, 2
in Nov 2017

- Replaced with a stand-off ring in PMT1 in Spring
- RTV layer measured
 - ~0.14 mm (PMT1)
 - ~0.06 mm (PMT2)

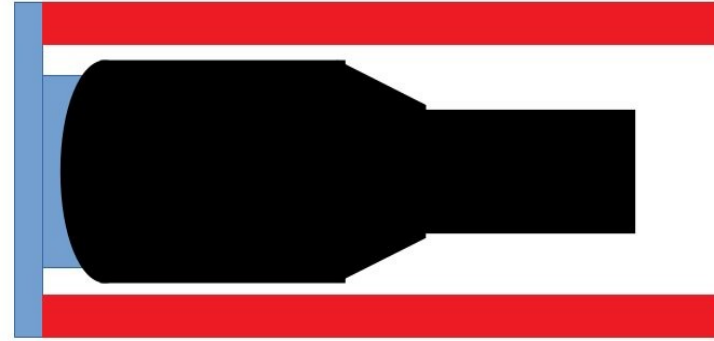
Before:

Quartz Window + Quartz adapter + RTV (130 micron) + PMT UV glass

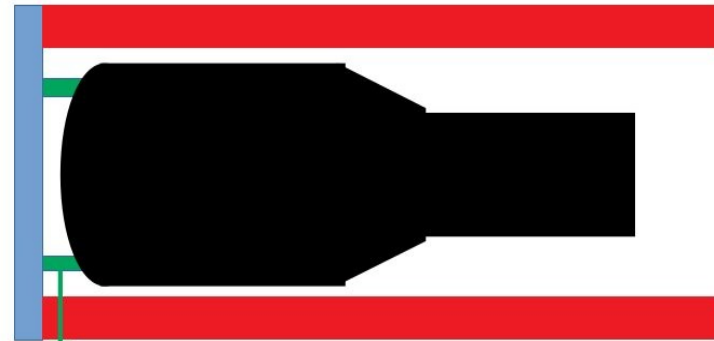
After:

Quartz Window + Air gap (5 mm) + PMT UV glass

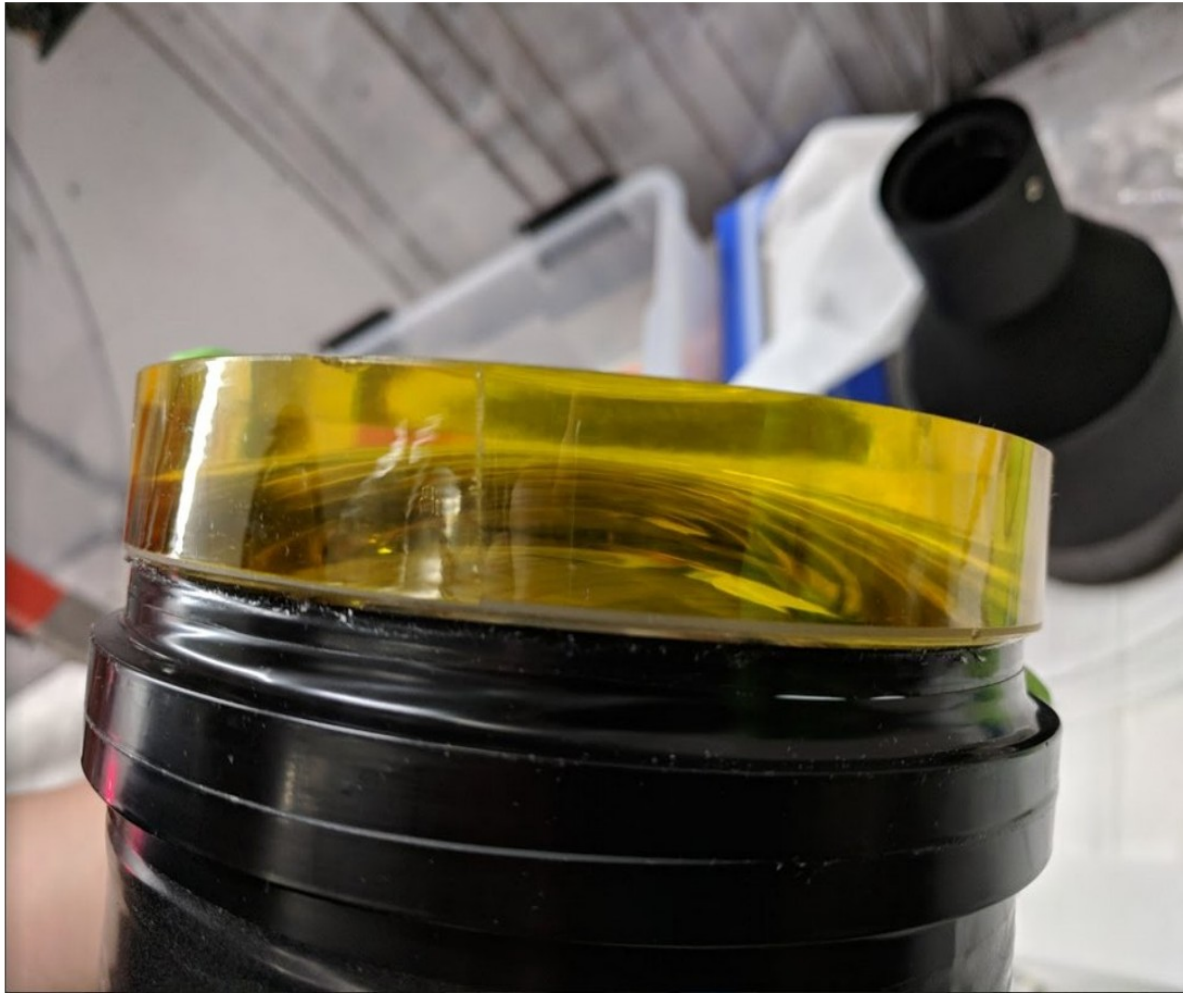
Plastic Ring

Al wall

Side view of quartz adapter on PMT 1 (now removed)

Note: Yellow color is due to kapton tape around perimeter of quartz adapter, NOT radiation damage.

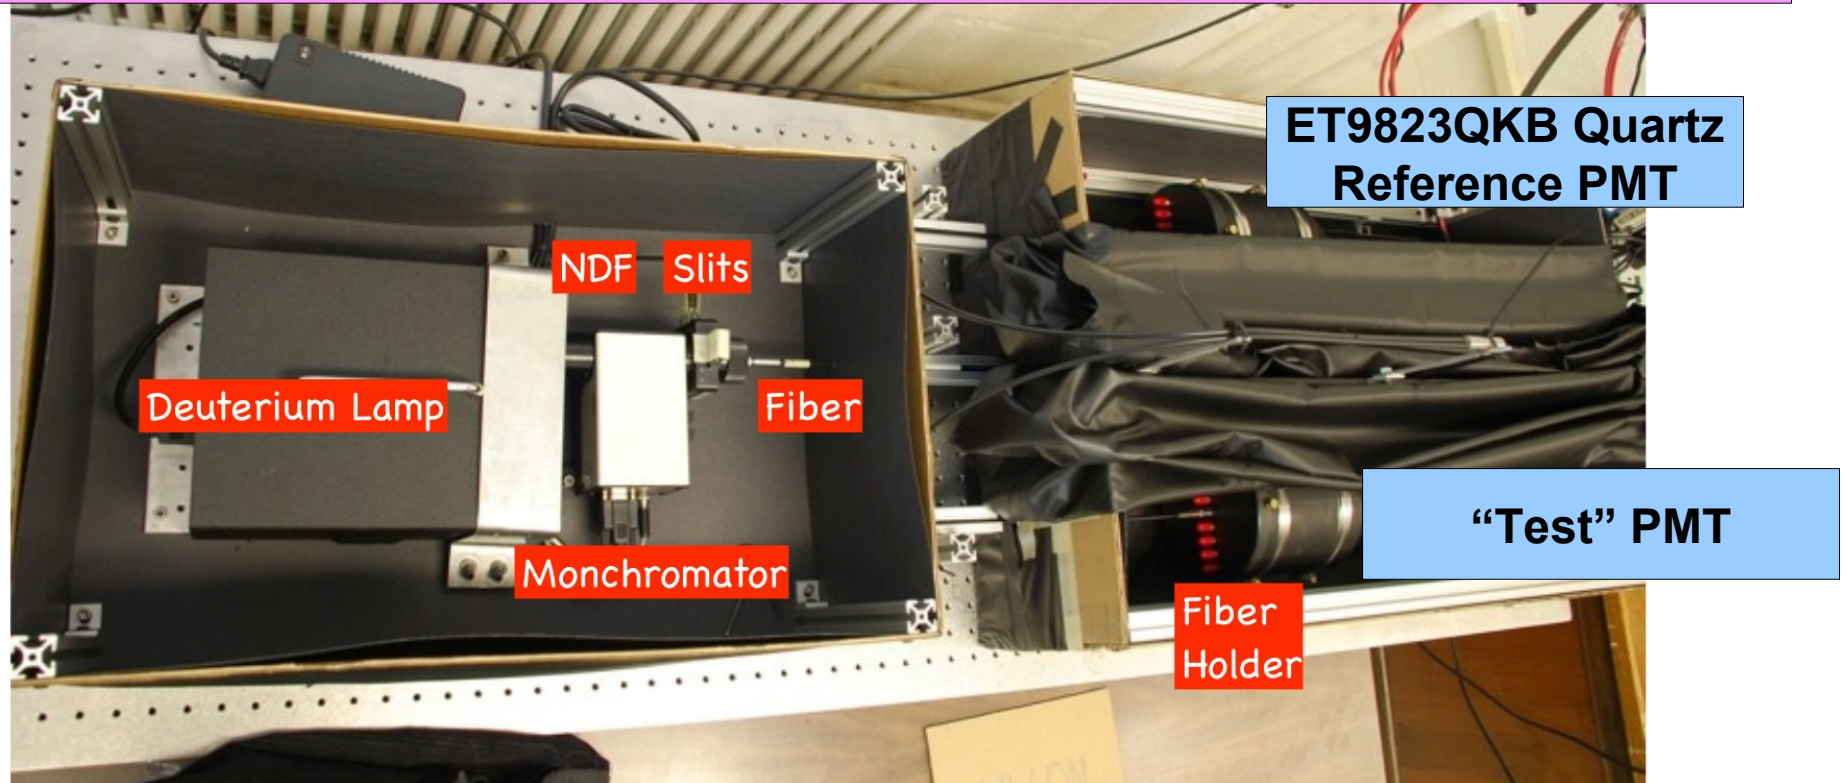
UVa PMT Test Stand

Normalization required for absolute QE measurement

- Difficult, not needed, so we did not do it.

Measurements are relative not absolute

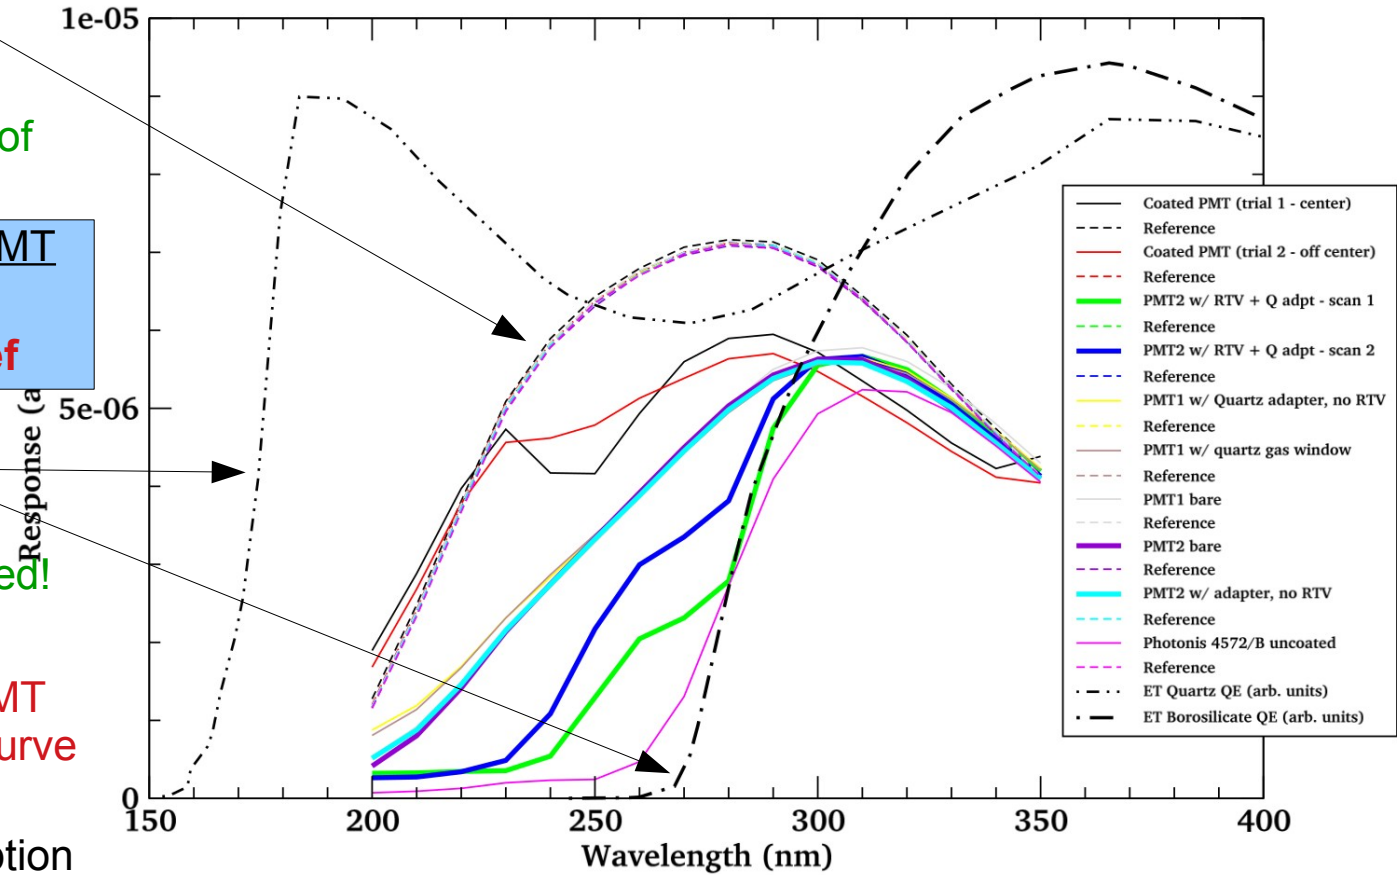
PMT response vs. wavelength

- 'Reference' PMT is ET 9823QKB Quartz-face (dashed curves)

- monitors lamp stability
- reflects spectral response of the system as a whole

Represents "Best Case" PMT response

- Dash-dotted lines indicate QE curves for (ET) Quartz and Borosilicate PMT

- w/ arb. scaling factor applied!

- Difference between Ref PMT response and quartz QE curve reflects system response

» Lamp intensity, absorption in fibers, etc

Note: Ref curves are unmodified; curves for each PMT scaled to match at ~350nm

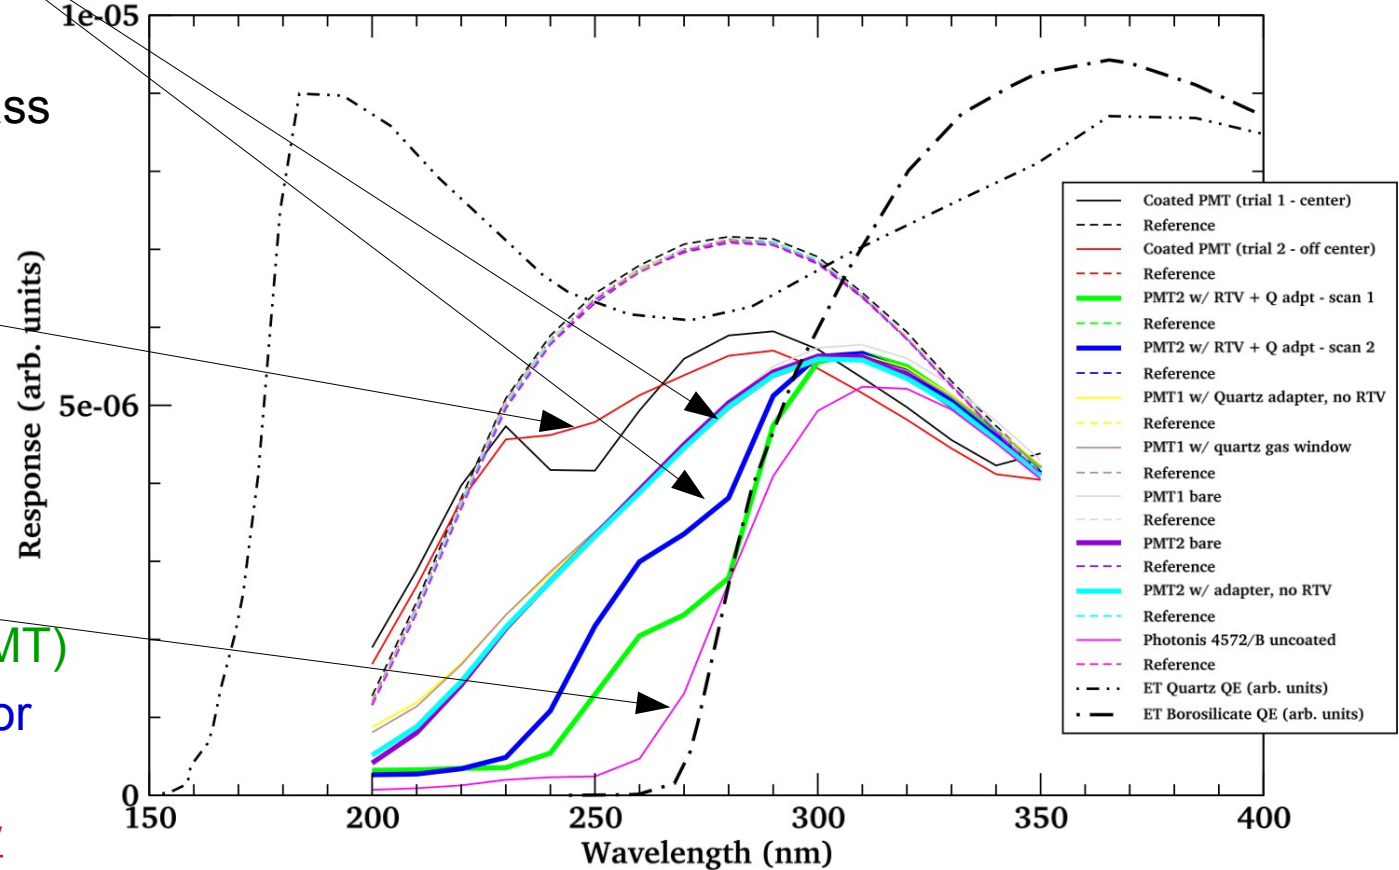
PMT response vs. wavelength

- Tested 4 'JLab' PMTs

- PMT1, PMT2

- » HGC prod. PMTs
- » Hamamatsu UV glass
- » Different optical elements involved

- 'Coated PMT'

- » Photonis 4572/B from Hall A, Borosilicate PMT w/ p-terp. coating

- Photonis 4572/B uncoated (different PMT)

- NOTE: Arbitrary scale factor between each PMT type

- Compare shapes only

Note: Ref curves are unmodified; curves for each PMT scaled to match at ~350nm

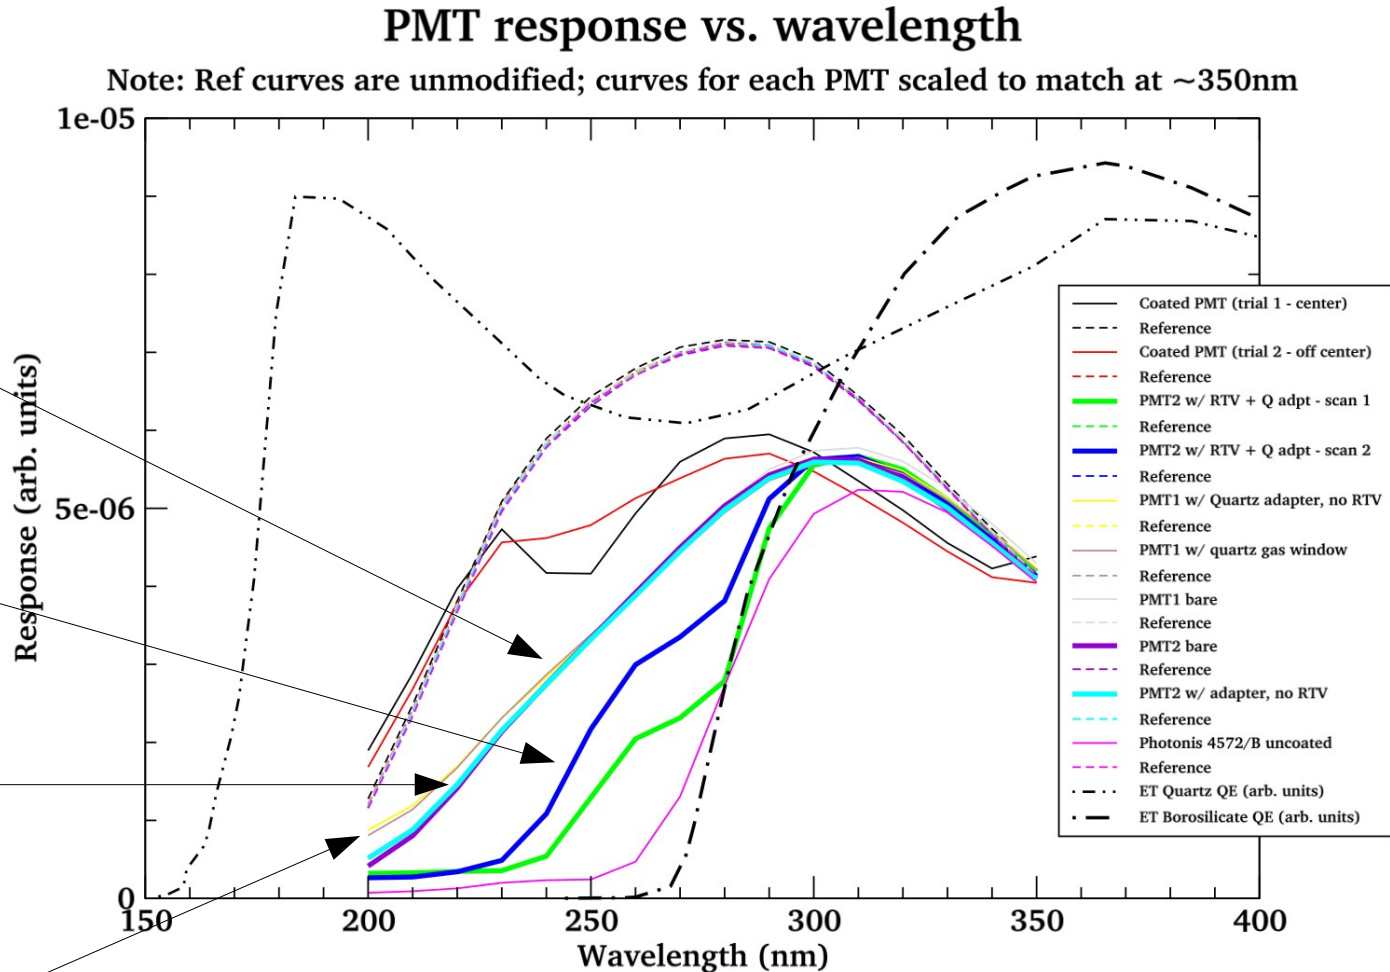
'Production' PMT responses

- **PMT1** (light lines)
 - **Prod. PMT that had all 'interface' parts removed**
 - » no adapter, no RTV, no opt. grease
 - **As expected**
- **PMT2** (heavy lines)
 - **Production PMT**
 - » w/ adapter + RTV
 - **degraded**
 - » adapter + RTV layer (0.06 mm) removed
 - **same response as PMT1**
- **Quartz glass PMT adapter and gas window tested**
 - **transparent (no impact)**

- SHMS HGC PMTs really *are* UV glass
- Quartz gas windows and quartz PMT adapters *are* transparent in UV
- RTV layer cuts enough that we should remove it (PMT adapter goes too)
- Also picked up ET 9823QKB replacement PMT for SHMS NGC from Donal
 - Replace noisy tube
- **Next Steps (ASAP)**
 - Remove RTV, quartz adapter, etc from upper PMTs
 - Re-insert bottom PMTs
 - Reinstall HGC in stack
 - » Gain check with LED
 - Replace noisy *NGC* PMT too
- **Small puzzles / cautions (?)**
 - *Before and After* npe response of PMT1 *in production* showed no/minimal improvement after removing RTV layer...
 - » I would not expect a major boost in photons in the Fall!

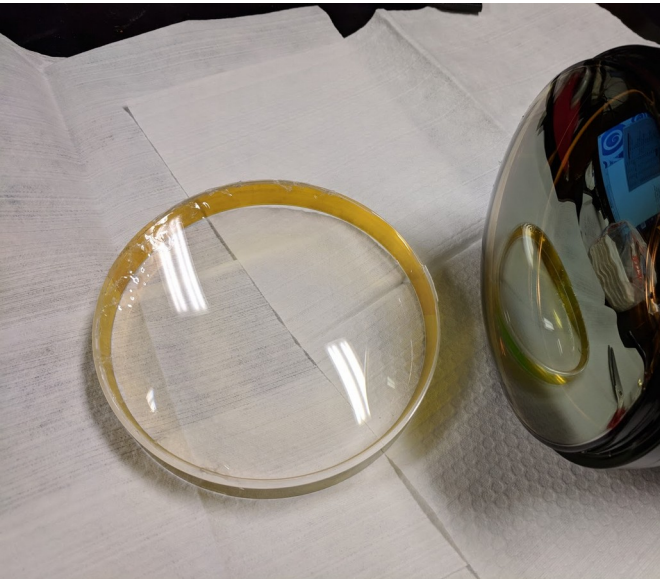
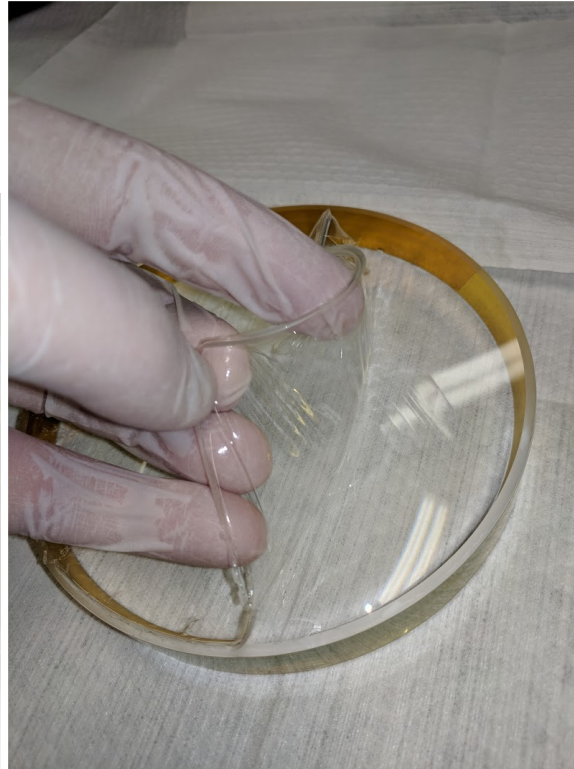
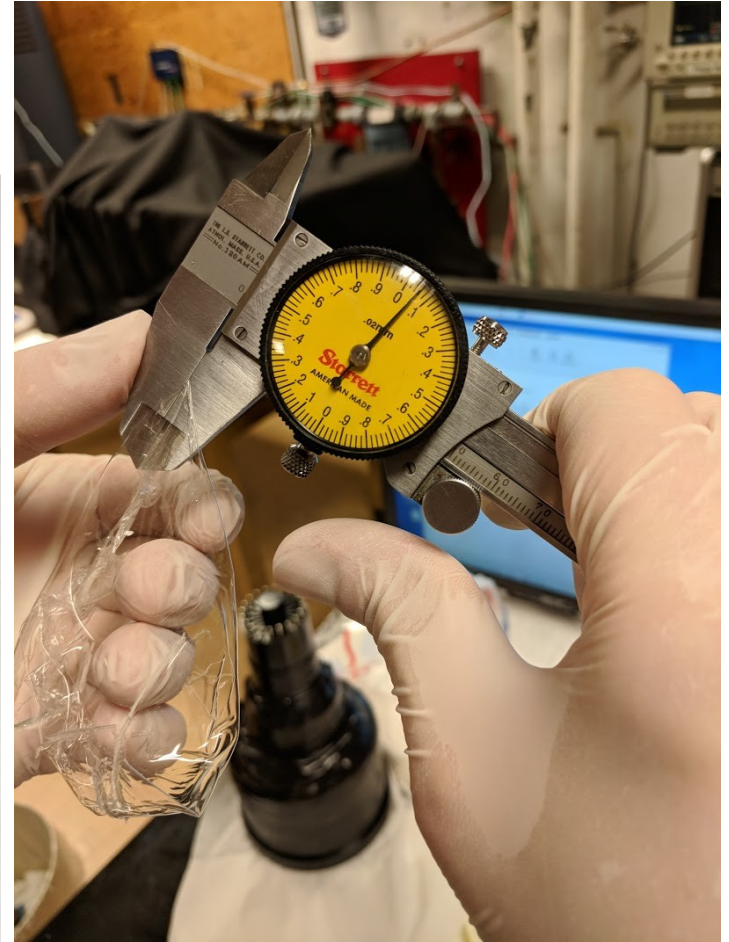
PMT2 Quartz Adapter Removed

- Quartz adapter on PMT2 removed at UVa
- PMT2 RTV layer thickness
→ 0.06 mm
