SHMS Q1 Radiation Damage

Jan 24, 2022
Hall C meeting
Steven Lassiter

Recent Log Activity Jan 11 to Jan 22 2022

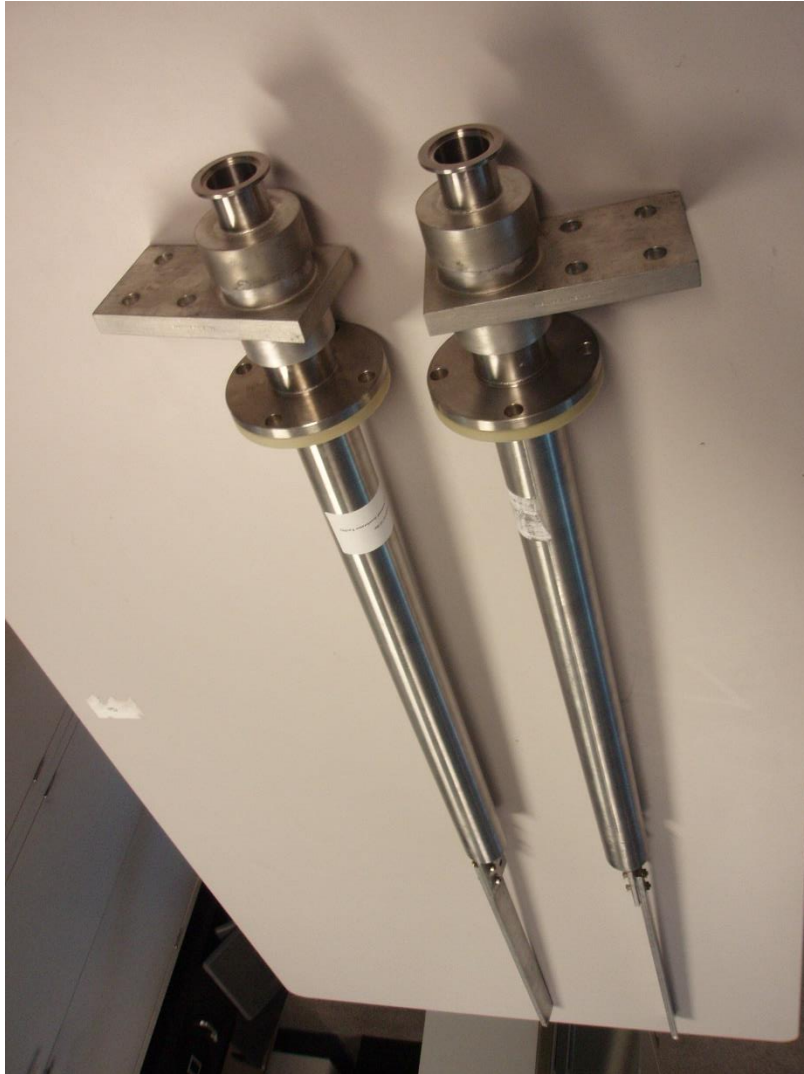
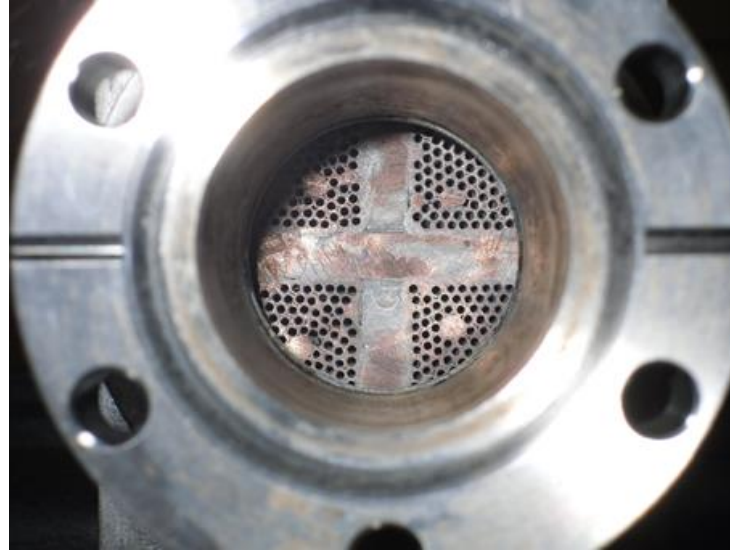
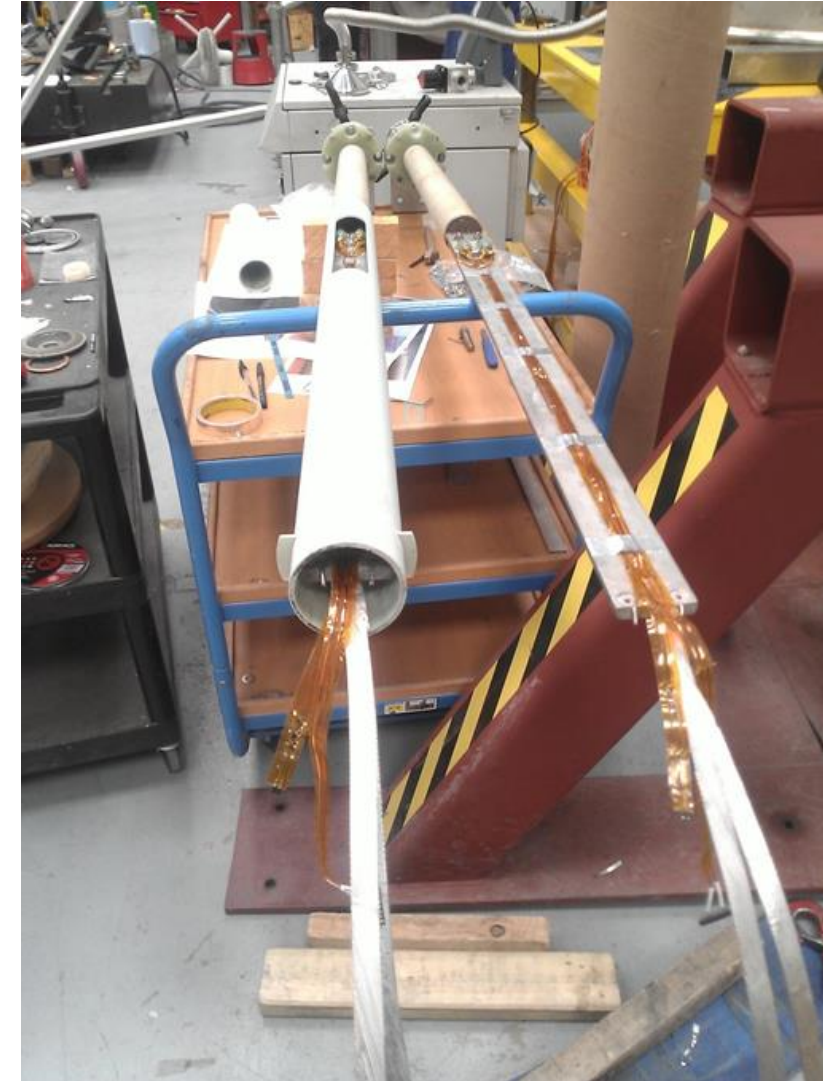
Current Lead Mass Flow Controller

Current Leads could become plugged from degradation of insulating material and B-stage binder material of the coils

- The Current Lead's Helium Mass flow controllers are mounted upstream of the current leads and have a finer mesh screen/pressure plate that the Helium gas passes through. This screen can be contaminated or clogged with B-stage or Kapton residue.
- Both meters were replaced. Right meter now shows signs of blockage as it's open position is nearly twice of the others to obtain the same flow.

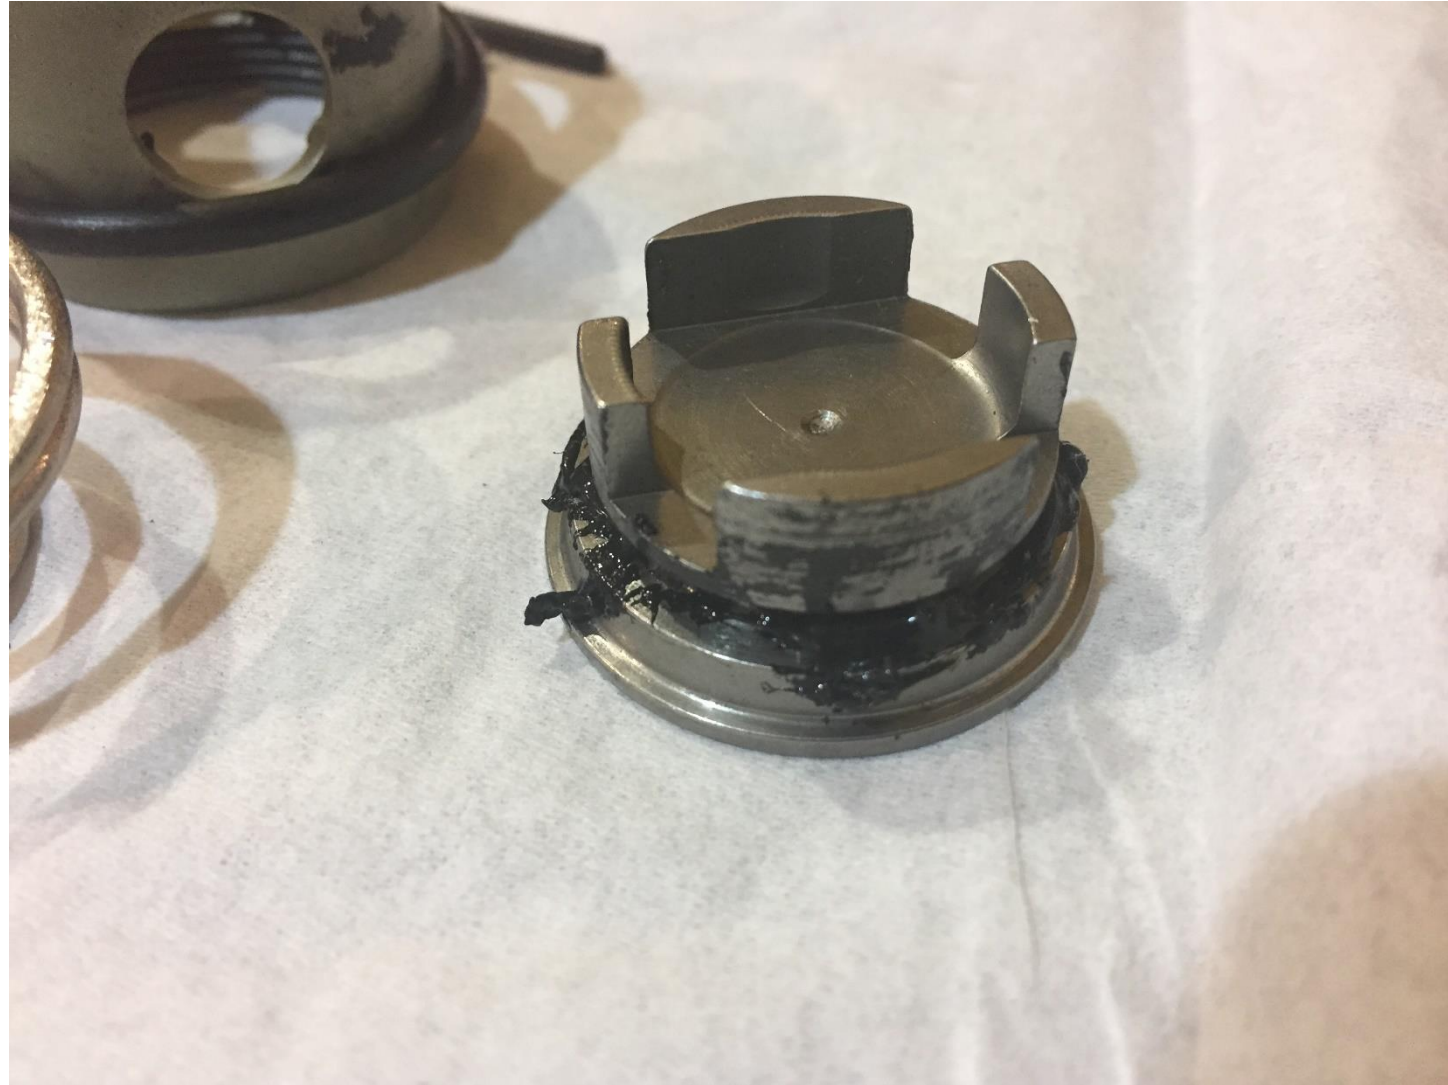
O-rings deteriorate to tar
CVI (or PHPK) O-ring leads to loss of vacuum in U-tubes and transfer
Lines

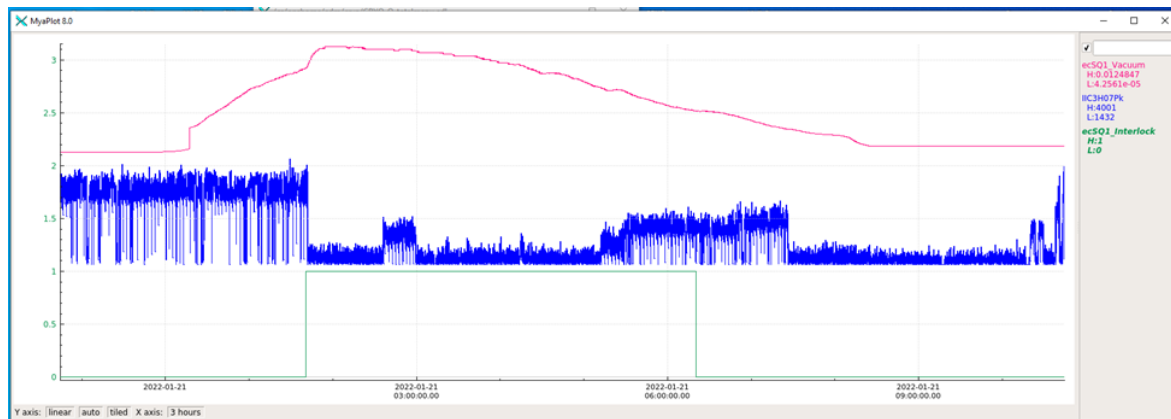
Vacuum Rise and recovery along with Beam Delivery

Evidence of Beam Radiation on Heating and Vacuum - Jan 21, 2022

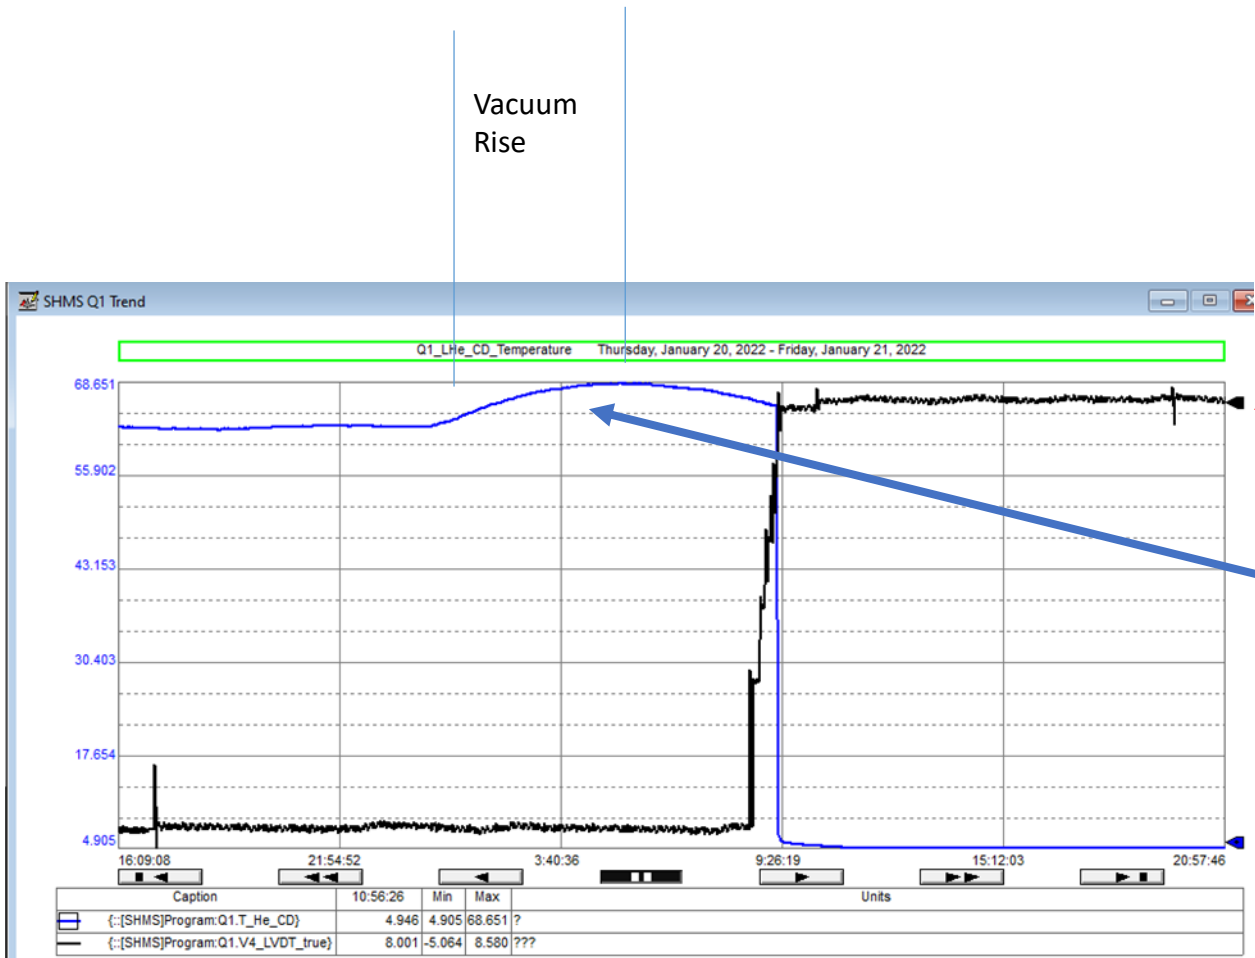
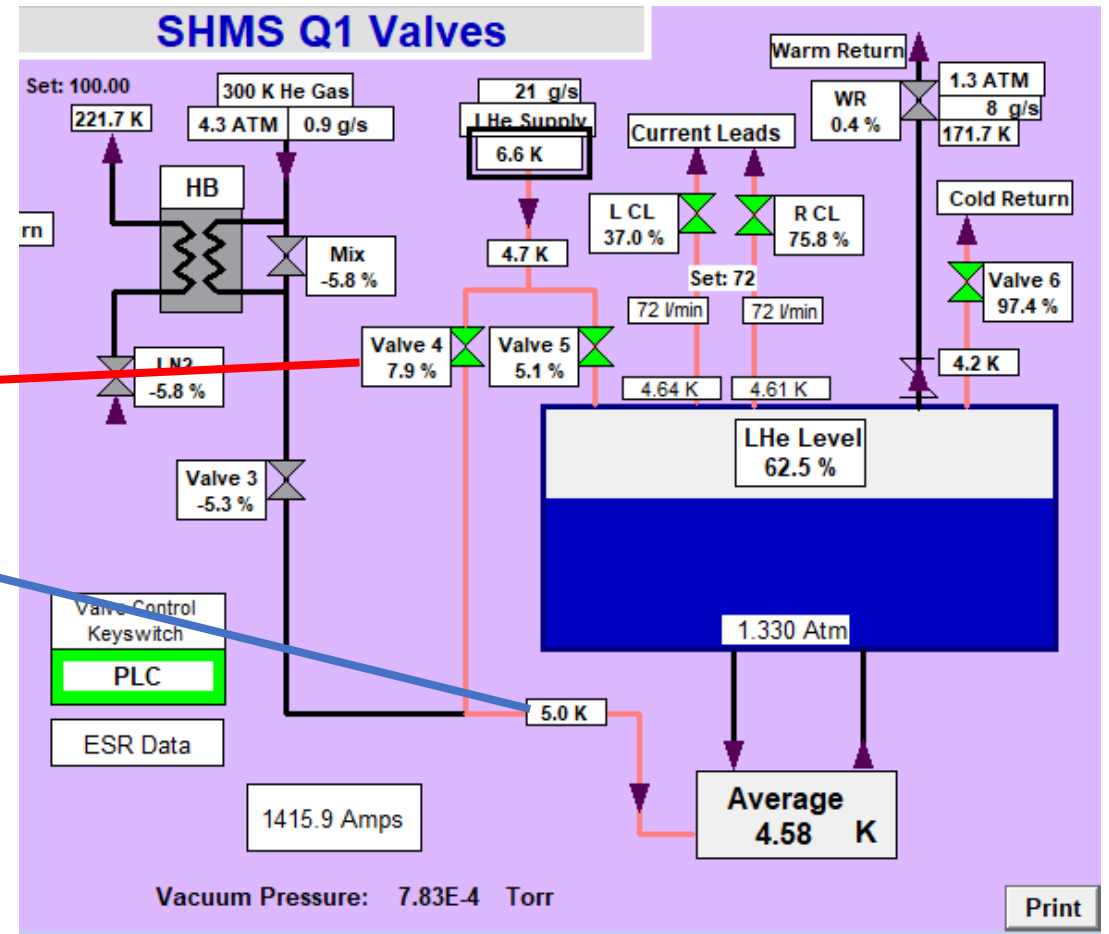
Took the additional step of using the Bottom Fill JT to cool more internal piping for additional Cryo-pumping capacity.
