NPS PMT Base Irradiation Test

V. Berdnikov, D. Mack

June 20, 2023

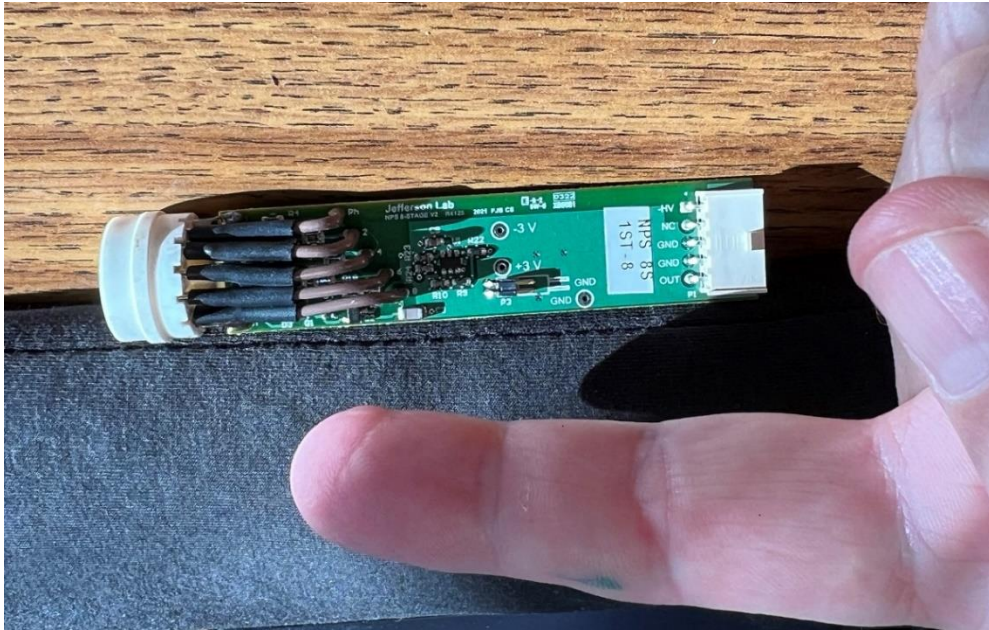
Figure 1 Amplifier side of a base. The two +3V test points are clearly visible, along with a convenient ground. The two voltage regulation chips are on the other side of the board.

Due to the need to measure energies over 2-3 orders of magnitude in dynamic range, setting up any high energy calorimeter is difficult. The NPS will take this challenge to the next level, since it will operate a high energy calorimeter with high scintillation light yield in a high luminosity environment. A sweeping magnet will reduce the low energy charged background, but due to high light levels from the remaining background, the gain of the PMT has to be no larger than $O(1000)$ to prevent excessively high anode currents¹. To match the NPS signal at the PMT anode to an FADC with 1 V full scale, the total gain needs to be $O(20,000)$, hence an amplifier with an effective charge gain of $O(20)$ is required.² Low noise amplification is essential to achieve high energy resolution since a single mV at the input to the amplifier corresponds to $O(300)$ MeV. Two voltage regulation chips were therefore added to the base to provide very low noise $\pm 3V$ power to the amplifier. In all, there are 3 solid state components which are well-justified but not previously tested for rad-robustness. (See Figure 1.)

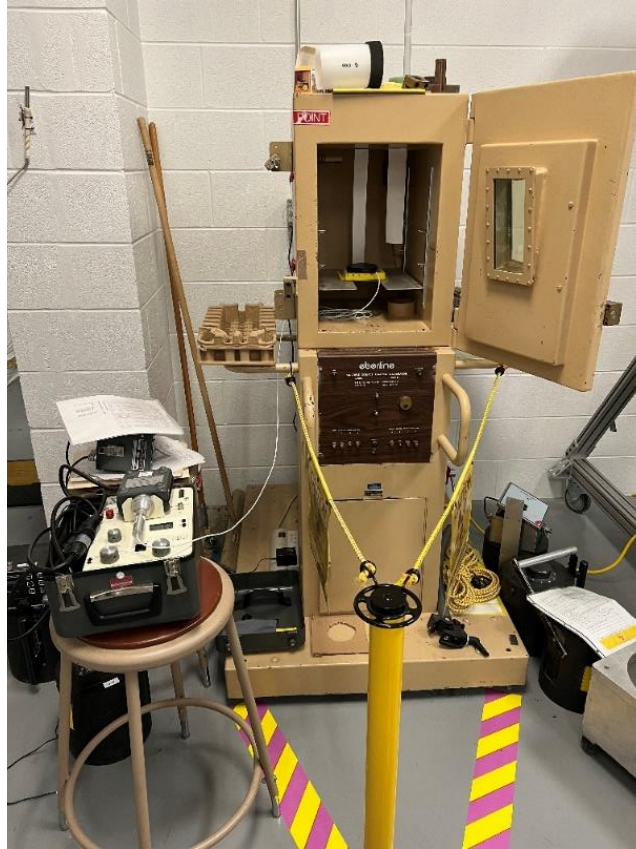
Figure 2 Cs-137 irradiator cabinet (before we moved in). When the door is shut and locked, and the shutter control rods are unlocked and pulled, a somewhat conical beam of beta and gamma rays comes out of a hole in the floor of the cabinet.

The Cs-137 irradiator on the RadCon test range was used. Figure 2 gives an impression of the workspace. During the current SAD, our access was usually limited because RadCon has so many radiation monitors to recalibrate. Most of our soaks therefore took place overnight or on a weekend.

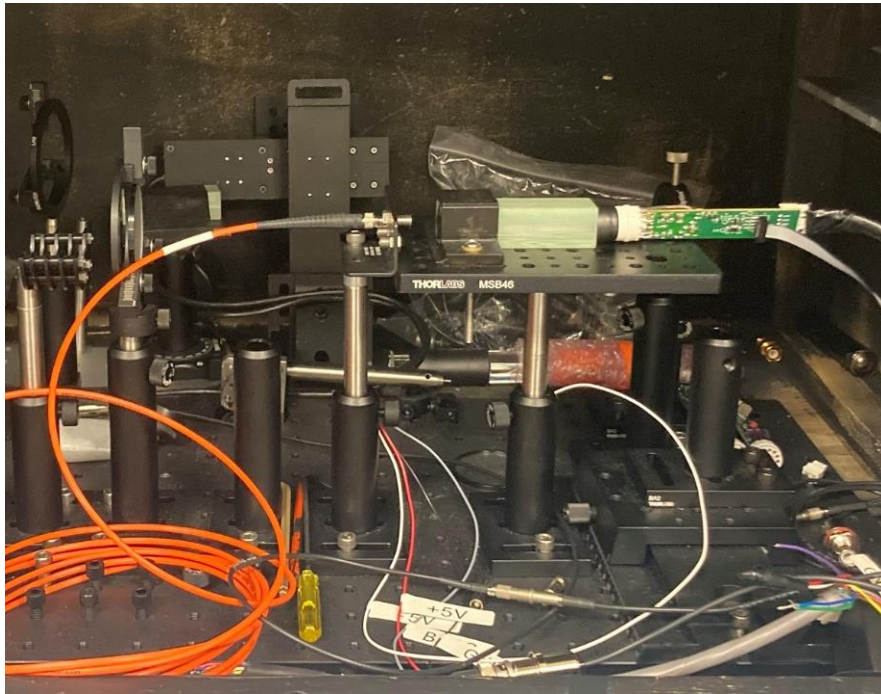
Figure 6 LED test setup in Fernando's lab. A PMT is attached to the base, and the LED pulses are brought in by the orange fiber cable.

Further tests on the 1st base were then done with a PMT and LED pulser setup as shown in Figure 6. The damaged base was confirmed to be completely non-functional at +-3V LV with the HV at 605V. But at +-5V LV, there was a spark of life: a signal which was over 2 orders of magnitude smaller than the control, and with a noticeably slower fall-time than the control. (See Figure 7.) Interestingly, the DC offset of the damaged base improved at the higher LV setting, decreasing from over 1V to “only” +170 mV. There are scenarios where the FADC could continue to operate with such a large DC offset, but with such low gain there would be no hope of increasing the HV enough to compensate. As we’ll see with the 2nd base studies below, the peculiar 100 MHz oscillations on the tail of the pulse only seem to appear in bases that are essentially dead.

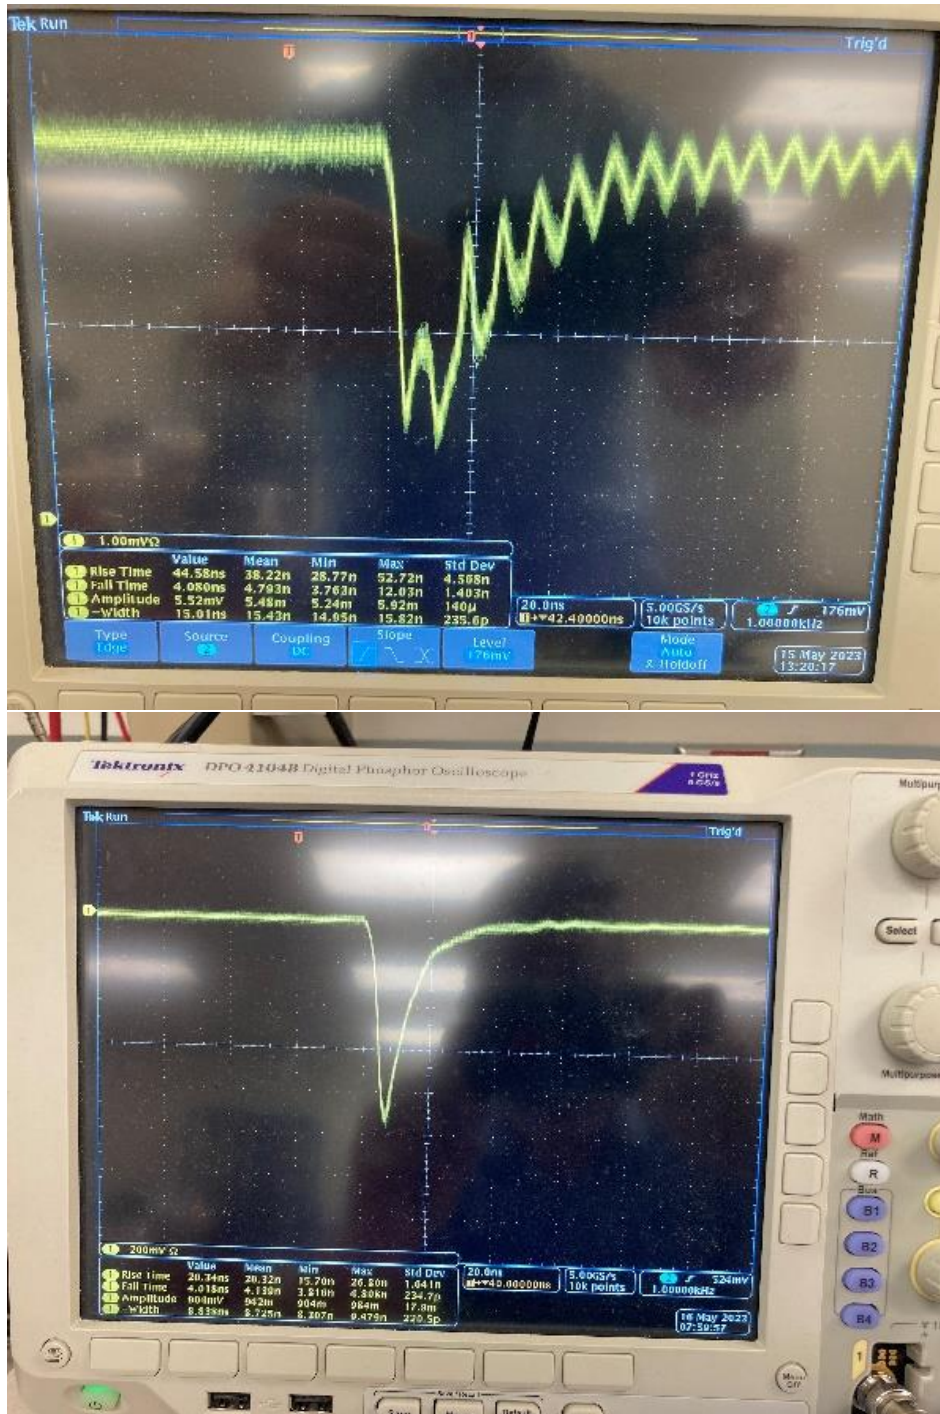
Figure 7 (Top) After increasing the LV to +5V, the 1st damaged base yields a 5 mV pulse in the LED test setup. (Bottom) With the same PMT, an undamaged base gives a 950 mV pulse with a noticeably shorter fall-time. The operating HV for the PMT was 610V in both cases.
