# NPS PMT Base Irradiation Test

## Abstract

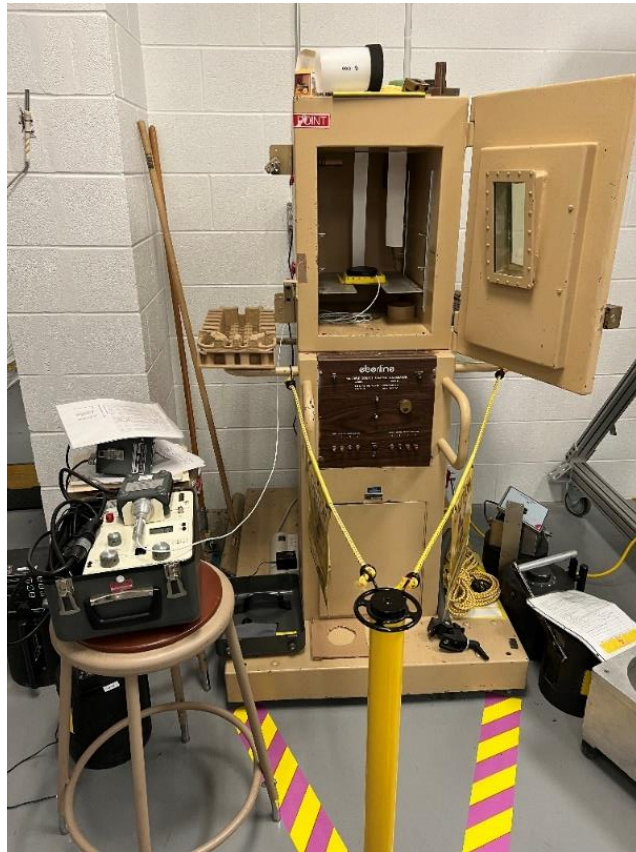
Figure 2 Cs-137 irradiator cabinet (before we moved in). When the door is shut and locked, and the shutter control rods are unlocked and pulled, a somewhat conical beam of beta and gamma rays comes out of a hole in the floor of the cabinet.

The Cs-137 irradiator on the RadCon test range was used. Figure 2 gives an impression of the workspace. During the current SAD, our access was usually limited because RadCon has so many radiation monitors to recalibrate. Most of our soaks therefore took place overnight or on a weekend.

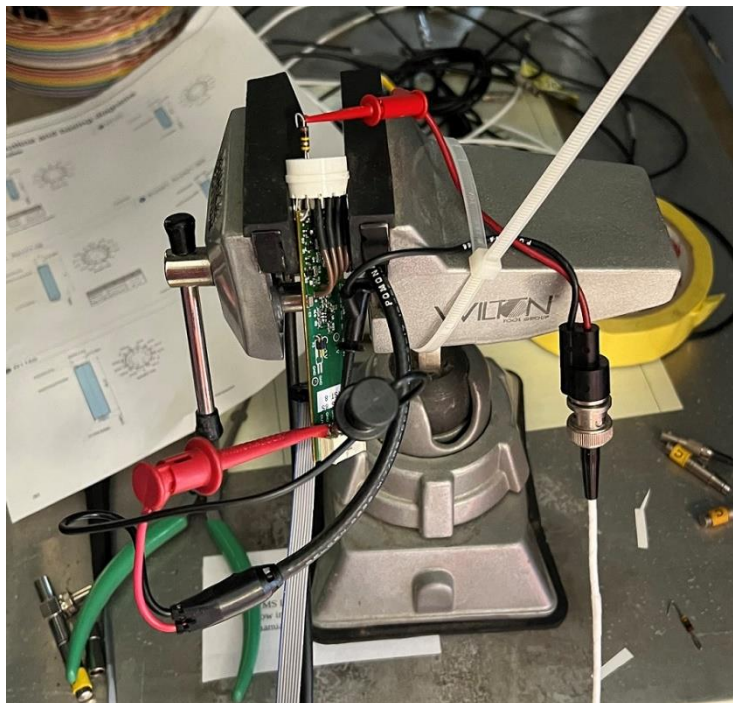
Figure 4 Bench view of how the pulser signal is injected into the PMT anode through a large resistance. (Near the top.) The resistor lead is cut to about half length, folded into a V shape, and plugged more or less securely into the PMT socket.

The irradiation test was delayed for weeks while we figured how to stably inject a signal into the amplifier. Connecting a pulser through even the shortest cable caused the amplifier output to oscillate at  $\pm 1\text{V}$  and 250 MHz. (Presumably because we were loading the amplifier input with capacitance and antenna noise.) Injecting the signal through a large resistance as in Figure 4 was ultimately successful. However, most of the pulser signal traveling down the  $50\ \Omega$  cable never makes it to the amplifier input because it reflects off the much larger impedance of the resistor. Values from  $100\ \Omega$  to  $1\ \text{M}\Omega$  were explored, the trade-off being between stable operation (which prefers a higher resistance) and the magnitude of the amplifier output (which prefers a lower resistance). A value of  $1\ \text{K}\Omega$  gave the best performance. Only a mother could love the amplifier output pulse seen in Figure 5, but it was adequate to monitor the effect of radiation damage on the signal magnitude or rise time or fall time.
