# NGC Base HV Breakdown Study

D. Mack

9/20/21

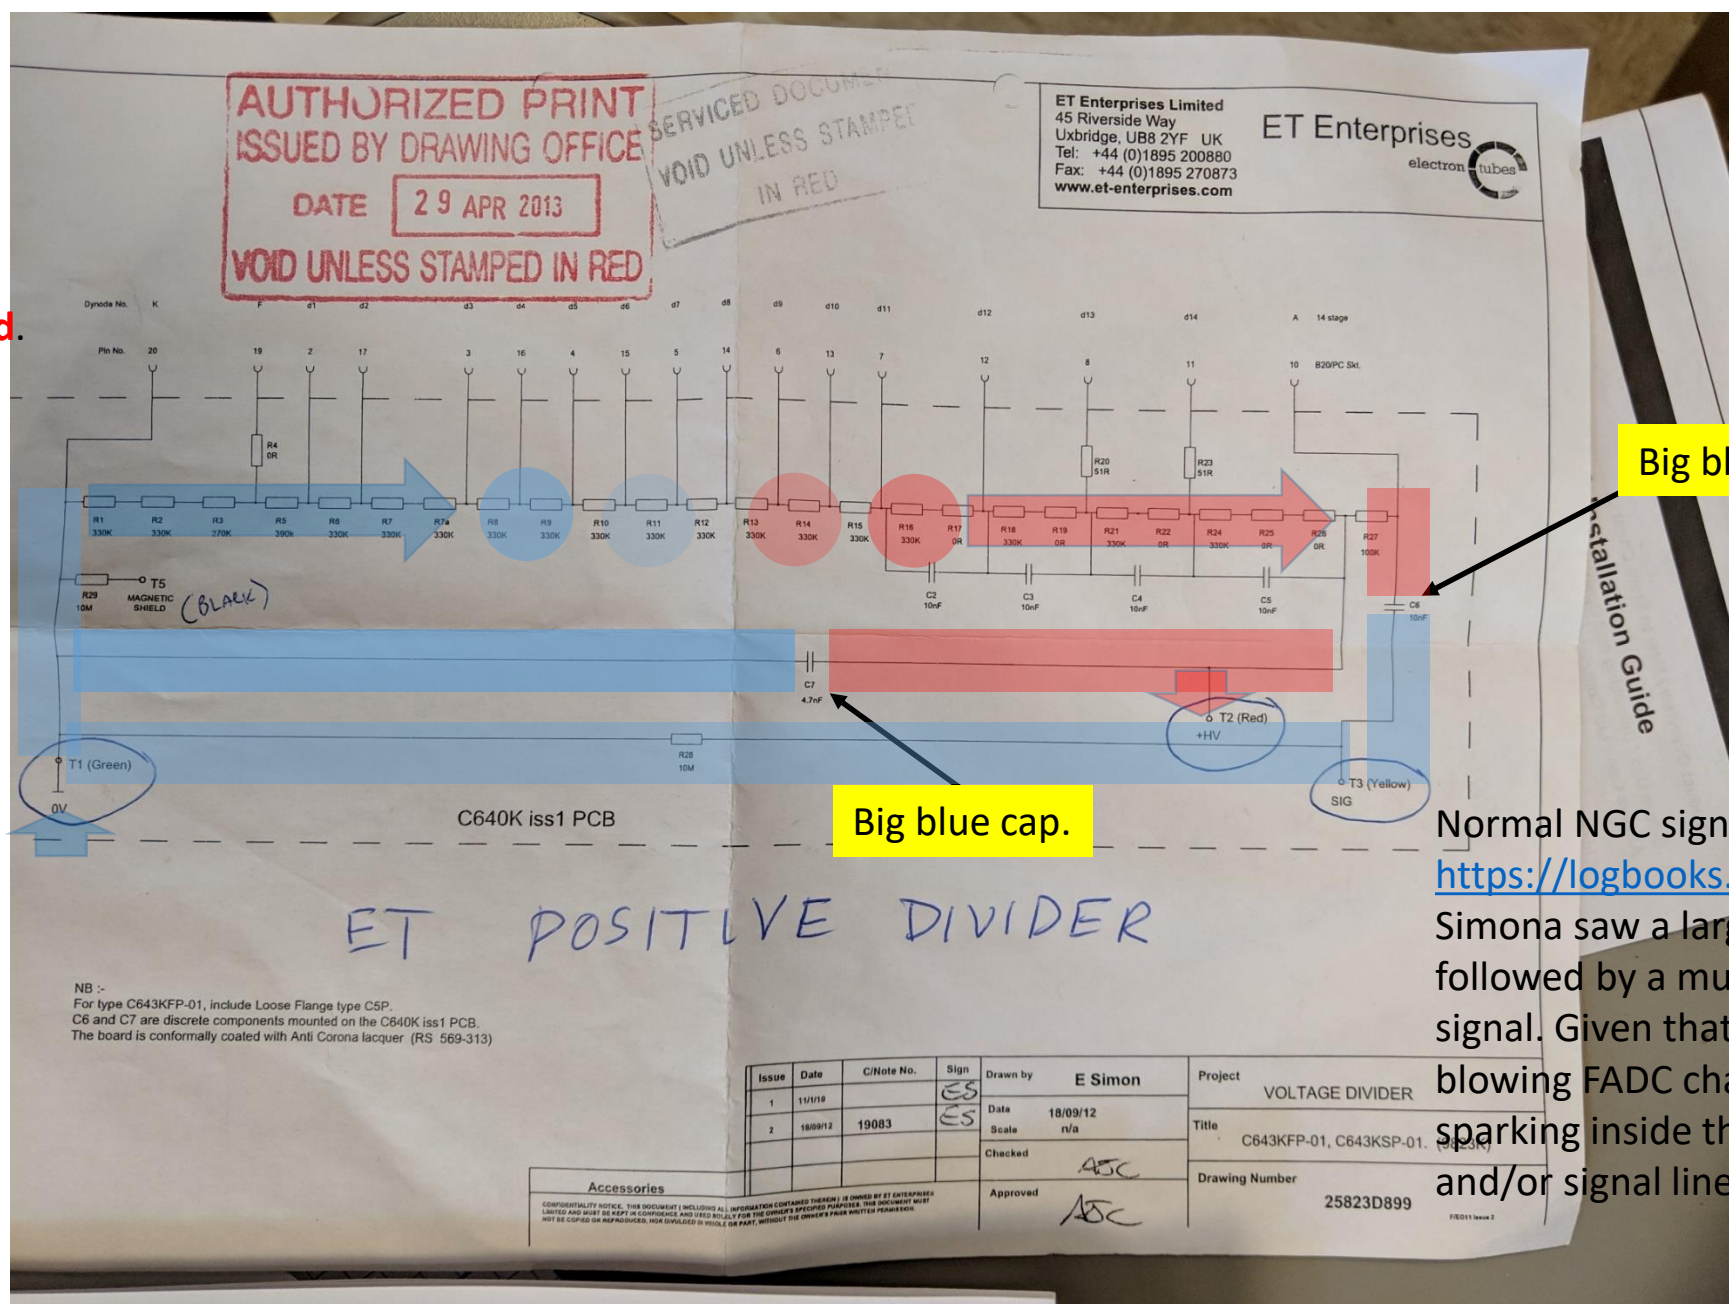
Here's the voltage divider diagram. Low potential areas in blue, and high potential in red.

Normal NGC signals are negative. In hlog <https://logbooks.ilab.org/entry/3901680>, Simona saw a large negative signal followed by a much larger positive signal. Given that we're occasionally blowing FADC channels, perhaps +HV is sparking inside the base to the ground and/or signal lines.

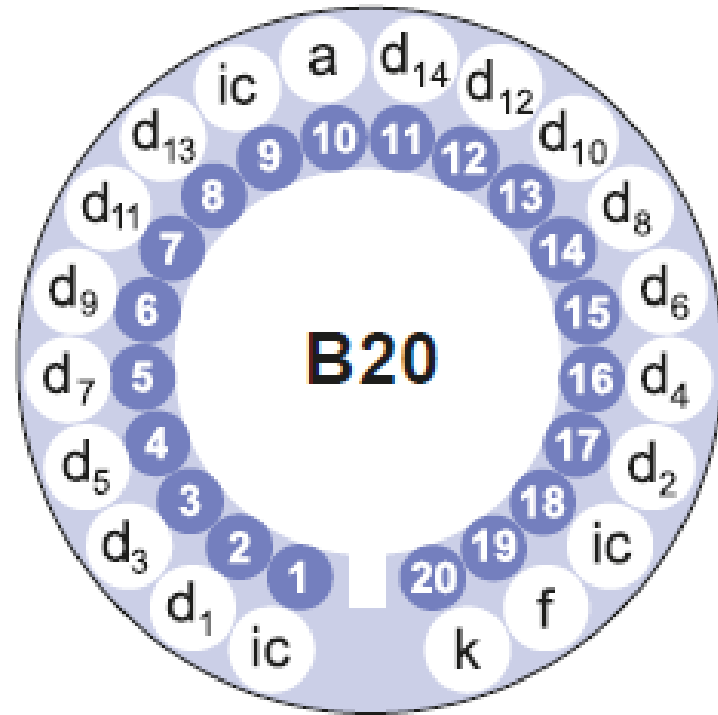
**B20 cap**  
**(for 9823KB)**

'ic' indicates an internal connection
