Report on the polarized target failure

Brief Description of UVa polarized target

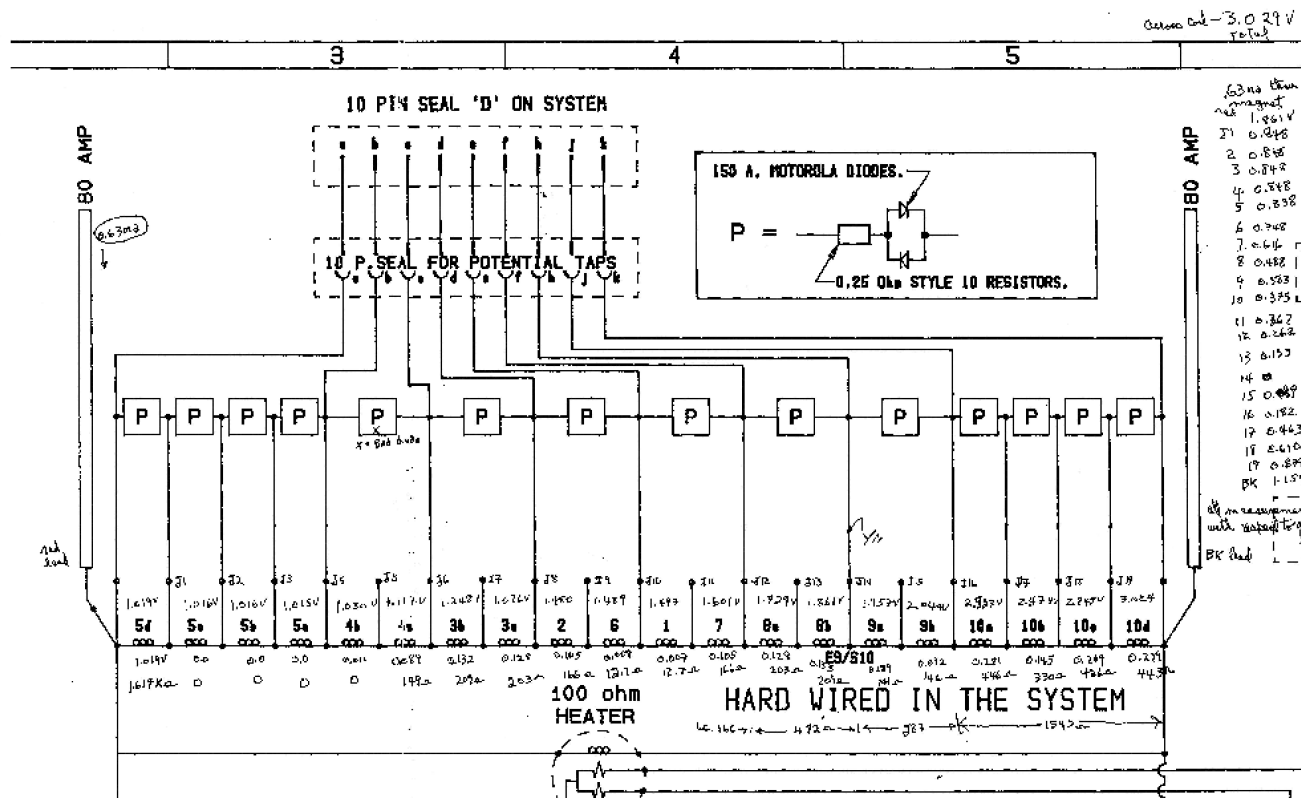
Fig. 3 is a circuit diagram showing how the coils are connected together and how the quench protection is incorporated. The quench protection circuit consists of a 0.25 Ohm resistor and pair of barrier diodes (denoted by “P” in Fig. 3). One half of the Helmholtz pair consists of 10 coils (labeled 5a-d, 4ab, 3ab, 2 and 6 in Fig. 3) and the other half is matching set of 10 coils (labeled 10a-d, 9ab, 8ab, 7 and 1 in Fig. 3). Leads for the superconducting coils are brought out of each coil and superconducting connections

are made from one coil to the next at the top of the magnet. The superconducting joint is made by soldering together the ends of 4ft of cable (from each coil) that has been first twisted together. This joint is placed in a cup that is then filled with Woods metal and a connection to the quench protection circuit is made. Taps are connected to circuit at selected points for diagnostics (This is indicated as 10 pin seal "D" in Fig. 3). The lead from the power supply is connected to coil 10d and the opposite power supply lead is connected to coil 5d. The power supply leads are connected in parallel to the persistent switch (resistance of 100 Ohms).
